Surveyor: Zaw La

Date Visited: 13.10.2015

No	Item	Condition	Description and Photos
1	Condition of -		
	(1). Well	Improved <input type="checkbox"/> Same <input checked="" type="checkbox"/> * Worse <input type="checkbox"/> <i>*as last week</i>	Description & Photos: -See ANNEX.1 - Although both of the two open wells are dirty, it seems that muddy water under the ground is passing through the crack at the wall of the well. Compared with last week, both wells cannot be used and therefore people use hand pumps, or rain water at the moment. In terms of avoiding the muddy groundwater passing to the well, both open wells need to be renovated again in summer. The buffers of some hand pumps need to be changed, but people get water from their own well or rain water currently.

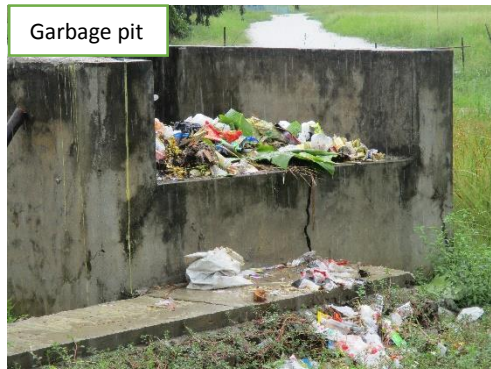
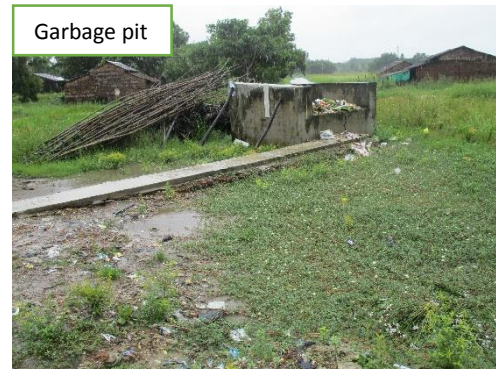
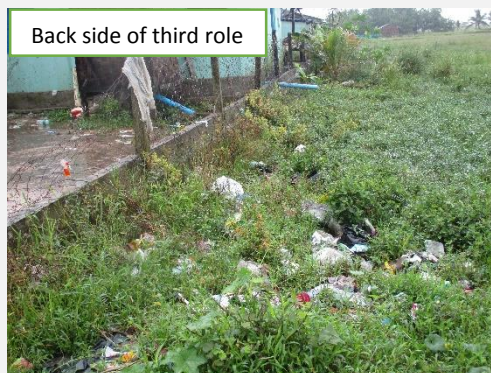
<p>(4). Garbage Condition</p>	<p>Improved <input type="checkbox"/> Same <input checked="" type="checkbox"/>* Worse <input type="checkbox"/></p>	<p><u>Description</u> -Garbage pit is being used by people. -Garbage pit was gradually increased with trash about half-full again and it needs to be collected again. -People throw garbage at the backside of Third Row and it needs to be clean up too.</p>
---------------------------------------	---	--

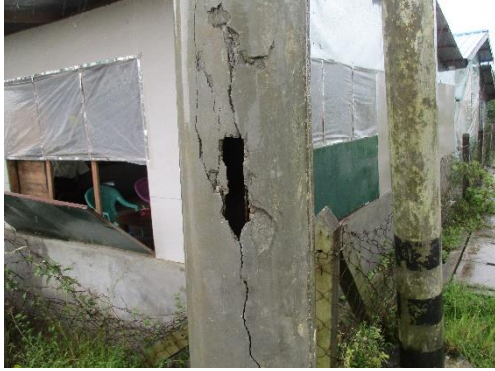
(6). Electricity	<p>Improved <input type="checkbox"/></p> <p>Same <input checked="" type="checkbox"/>*</p> <p>Worse <input type="checkbox"/></p> <p><i>*as last week</i></p>	<p><u>Description</u></p> <ul style="list-style-type: none"> -Electricity comes regularly. -Electric poles and transformer are being supported with a good foundation. -But, there is a hole at an electric pole which was hit by a truck car. The electric pole needs to be renovated. <p><u>Photos</u></p>	<div style="display: flex;"> <div style="width: 50%; text-align: center;"> <p>In front of HH No. 24</p>

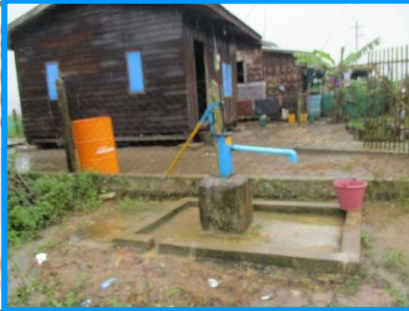
Water is clean and people nearby are using it for drinking and living use . A pulley wheel, bucket and a rope have been set up but the rope seems to be thin and it is better to be changed with thick one for the better use.

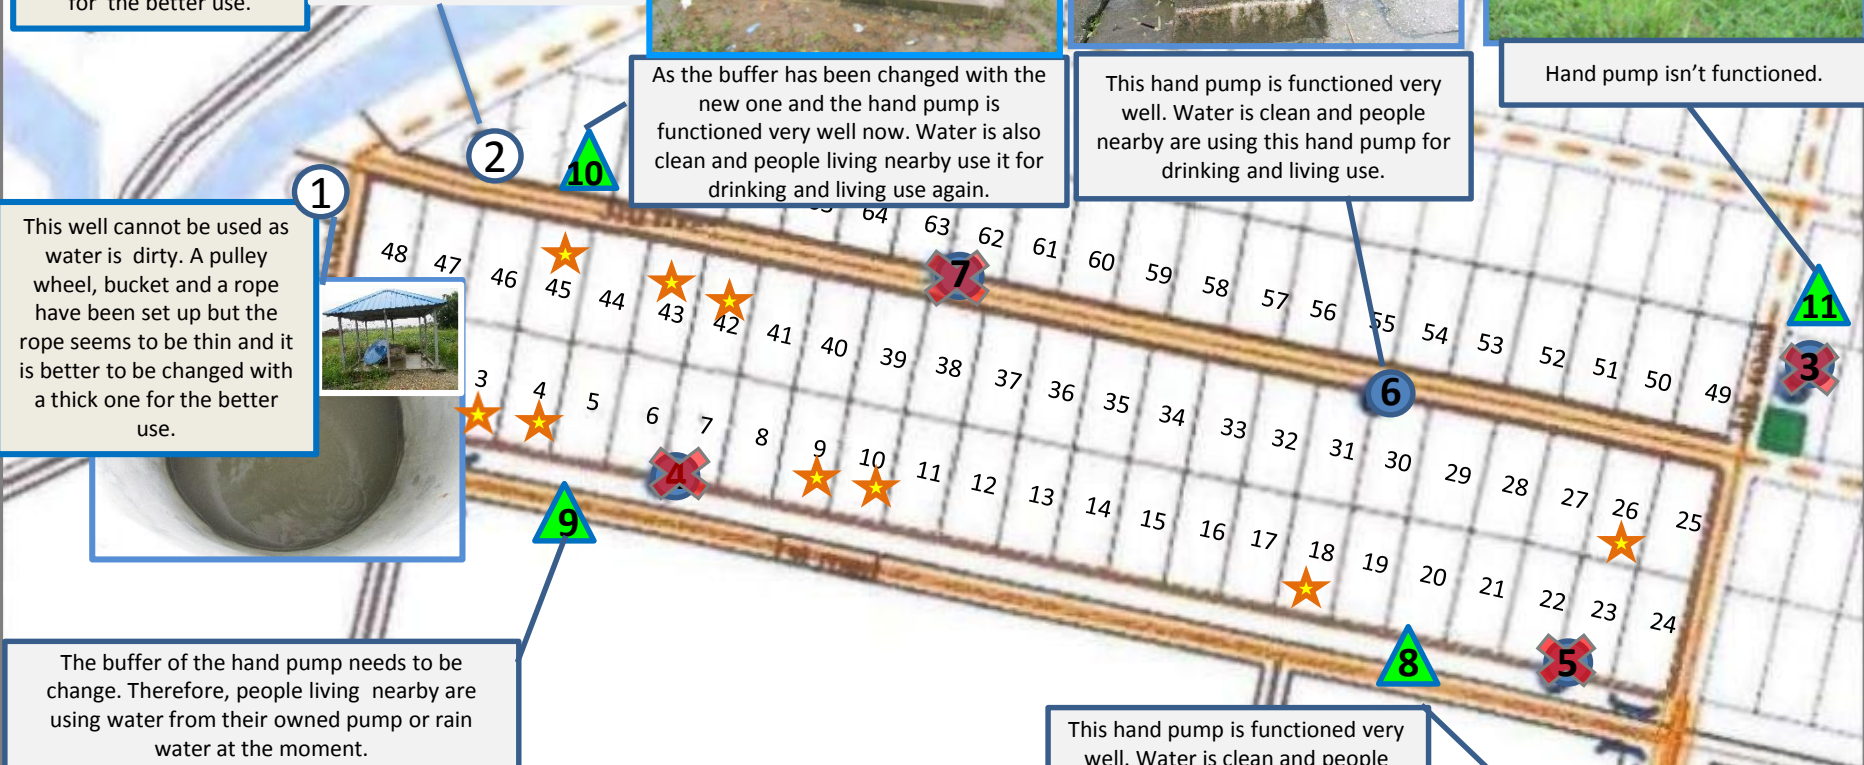
Hand pump isn't functioned.

The buffer of the hand pump needs to be change. Therefore, people living nearby are using water from their owned pump or rain water at the moment.
