Surveyor: Zaw La

Date Visited: 29.9.2015

No	Item	Condition	Description and Photos
1	Condition of -		
	(1). Well	Improved <input type="checkbox"/> Same <input checked="" type="checkbox"/> * Worse <input type="checkbox"/> <i>*as last week</i>	Description & Photos: -See ANNEX.1 - Although both of the two open wells are dirty, it seems that muddy water under the ground is passing through the crack at the wall of the well. Compared with last week, well no. 1 is gradually clean this week and used by surrounding people again. In terms of avoiding the muddy groundwater passing to the well, both open wells need to be renovated again in summer. The buffers of some hand pumps need to be changed, but people get water from their own well or rain water currently.

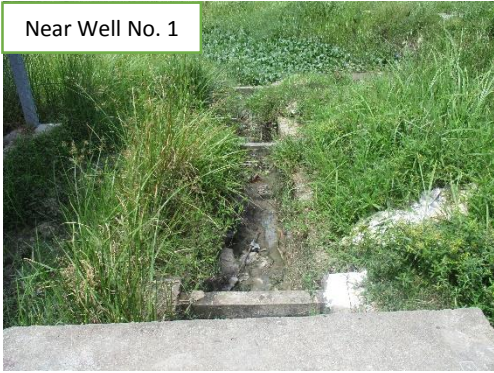
<p>Near Well No. 1</p> </div> <div style="width: 50%; text-align: center;">

(2). <u>Drainage</u>	Improved <input type="checkbox"/> Same <input checked="" type="checkbox"/> * Worse <input type="checkbox"/> <i>*as last week</i>	<u>Description</u> -Water level in the drainage canals is lower than last week because there was no rain for last three days ago. The stream along the drainage canal may need to be rehabilitated in order to improve the water-flow in coming summer period. <u>Photos</u> <div style="display: flex; flex-wrap: wrap;"> <div style="width: 50%; text-align: center;">

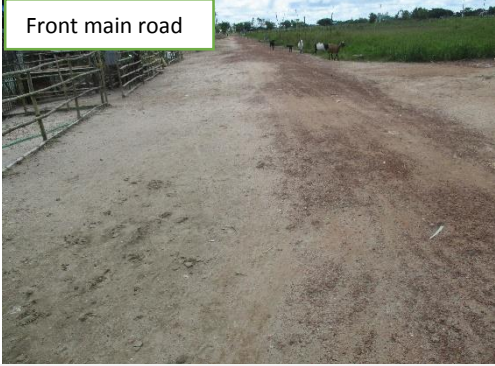
(3). Road	<p>Improved <input type="checkbox"/></p> <p>Same <input checked="" type="checkbox"/>*</p> <p>Worse <input type="checkbox"/></p> <p><i>*as last week</i></p>	<p><u>Description</u></p> <p>-The roads are almost being dry and no problem for walking.</p> <p><u>Photos</u></p>	<p>Front main road</p>

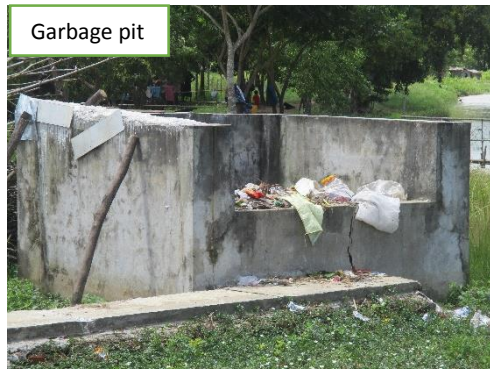
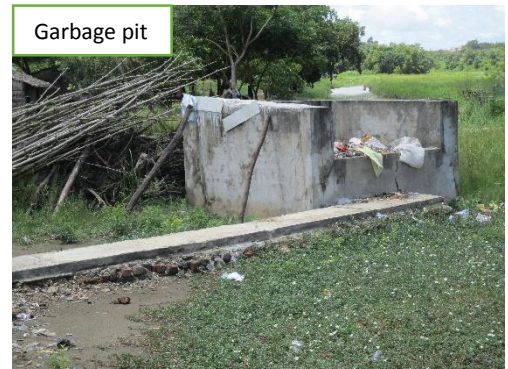
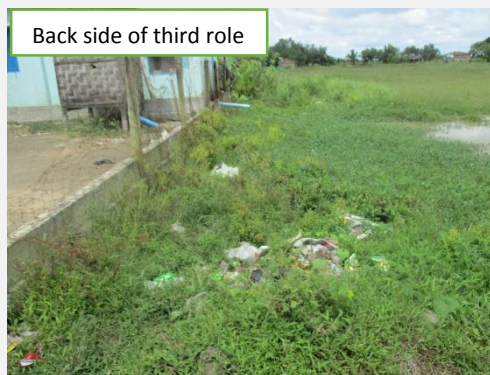
(4). Garbage Condition	<p>Improved <input type="checkbox"/></p> <p>Same <input checked="" type="checkbox"/>*</p> <p>Worse <input type="checkbox"/></p>	<p><u>Description</u></p> <p>-Garbage pit is being used by people.</p> <p>-Garbage pit was cleaned and a new access way to garbage pit had been constructed.</p> <p>-The garbage is half-full again but no problem for smelling from the garbage pit so far.</p> <p>-People throw garbage at the backside of Third Row and it needs to be collected.</p>

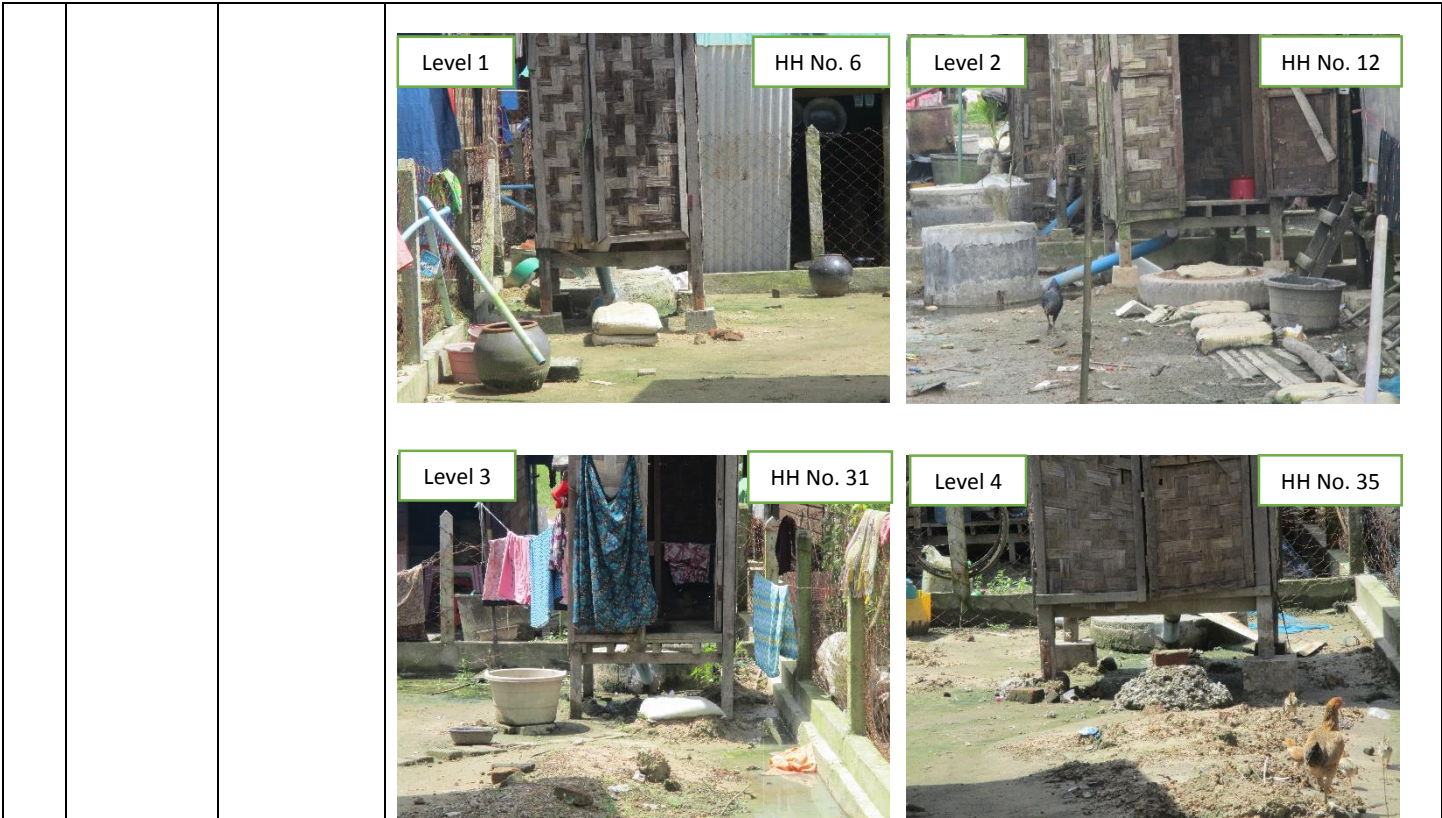
-All of fly proof toilets are used by people.
-Almost all of fly proof toilets made by wood or bamboo have been lifted up as shown in below pictures. Some concrete toilets are still needed to be renovated too as their floors are low and will be inconvenient to use sometimes when there is heavy rain and groundwater level is raised.

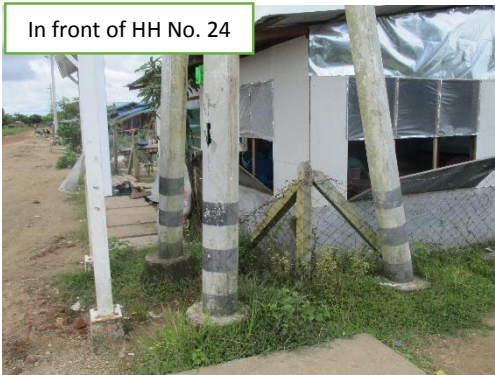
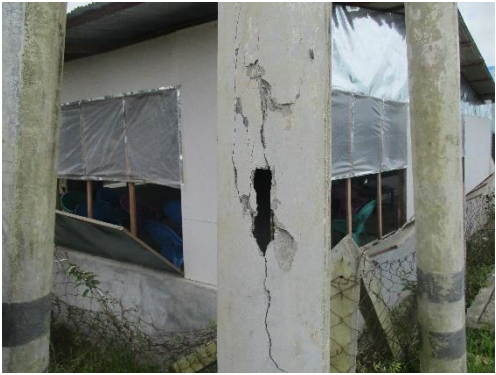
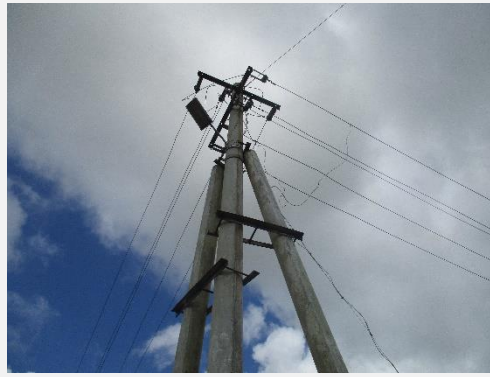
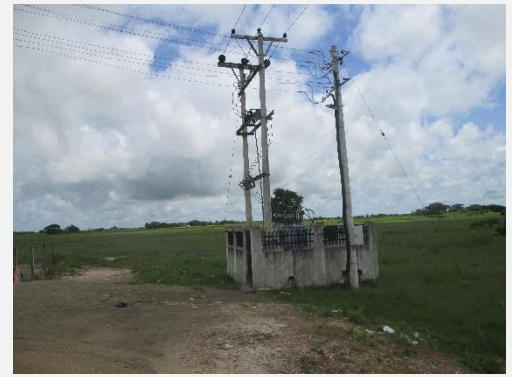
Description
 -Electricity comes regularly.
 -Electric poles and transformer are being supported with a good foundation.
 -But, there is a hole at an electric pole which was hit by a truck car. The electric pole needs to be renovated.

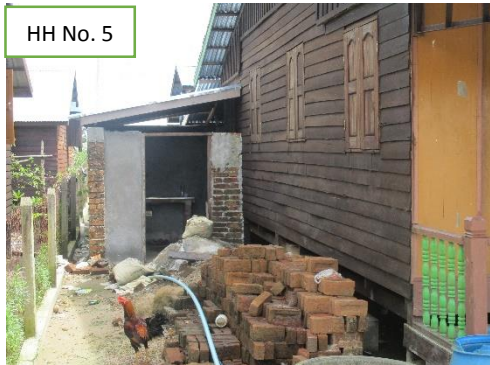
2	House Construction	No. of houses not completed (2)	<p><u>Description</u> -HH No.5, the construction for kitchen, toilet and water tank seems to start again.</p>

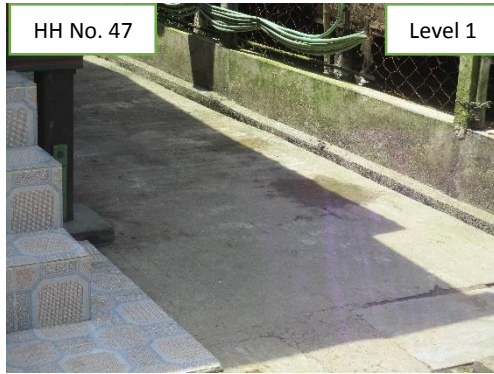
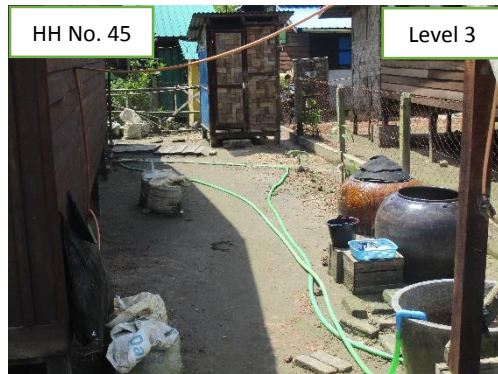
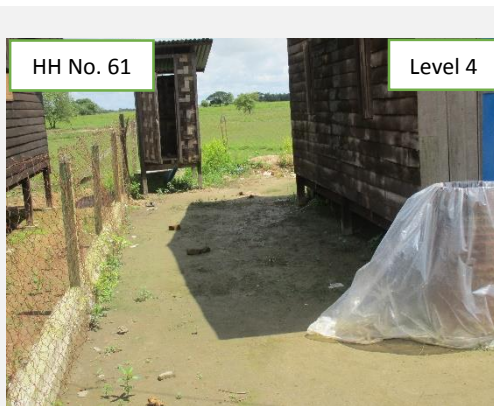
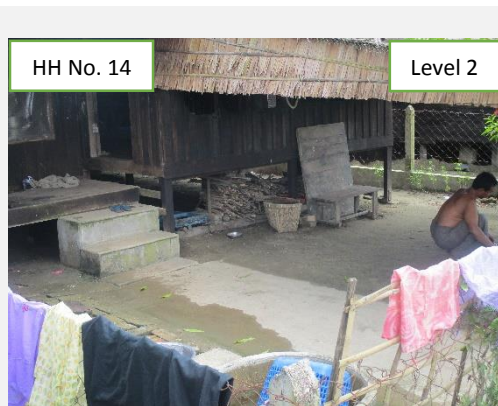
(1). Drainage condition for rain water in their compounds	<p><u>Description</u> -Rainy season has started. -Some of the compounds are wet.</p>

- No mud and no standing water in their compound
- Level 3**
- Some or little mud and standing water in their compound
- Level 4**
- A lot of mud and standing water in their compound

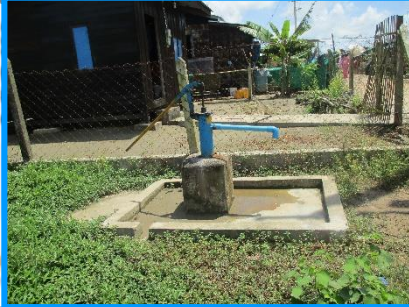
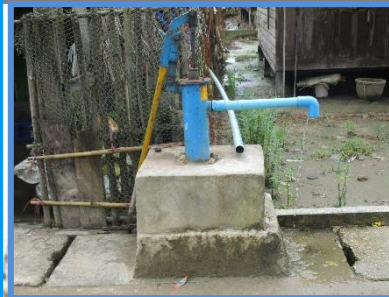
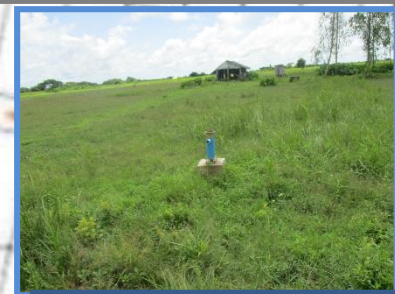
Water is clean and people nearby are using it for drinking and living use . A pulley wheel, bucket and a rope have been set up but the rope seems to be thin and it is better to be changed with thick one for the better use.

As the buffer has been changed with the new one and the hand pump is functioned very well now. Water is also clean and people living nearby use it for drinking and living use again.

This hand pump is functioned very well. Water is clean and people nearby are using this hand pump for drinking and living use.

Hand pump isn't functioned.

This well cannot be used as water is dirty. A pulley wheel, bucket and a rope have been set up but the rope seems to be thin and it is better to be changed with a thick one for the better use.

The buffer of the hand pump needs to be change. Therefore, people living nearby are using water from their owned pump or rain water at the moment.

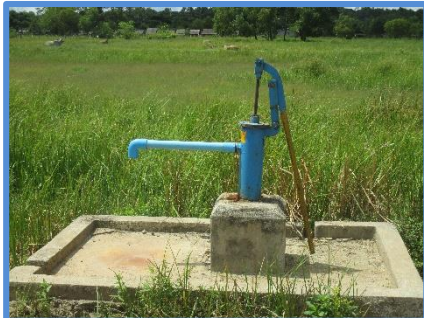
This hand pump is functioned very well. Water is clean and people living nearby are using this hand pump. Moreover water filter tank for remove the smell of iron has been set up beside the hand pump. There is no smell of iron and people enjoy water for drinking and living use.
