Surveyor: Zaw La

Date Visited: 16.9.2015

No	Item	Condition	Description and Photos
1	Condition of -		
	(1). Well	Improved <input type="checkbox"/> Same <input checked="" type="checkbox"/> * Worse <input type="checkbox"/> <i>*as last week</i>	Description & Photos: -See ANNEX.1 - Although both of the two open wells are dirty, it seems that muddy water under the ground is passing through the crack at the wall of the well. Compared with last week, well no. 1 is gradually clean this week and used by surrounding people again. In terms of avoiding the muddy groundwater passing to the well, both open wells need to be renovated again in summer. The buffers of some hand pumps need to be changed, but people get water from their own well or rain water currently.

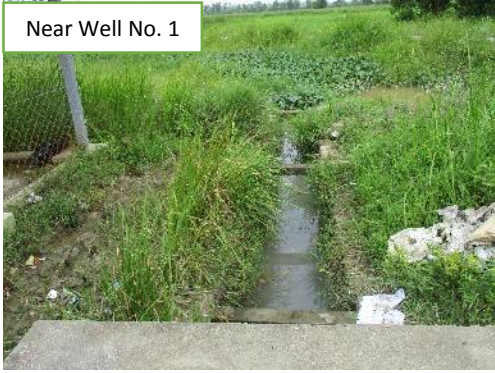
<p>Near Well No. 1</p> </div> <div style="width: 50%; text-align: center;">

(2). <u>Drainage</u>	Improved <input type="checkbox"/> Same <input checked="" type="checkbox"/> * Worse <input type="checkbox"/> <i>*as last week</i>	<u>Description</u> -Water level in the drainage canals is higher than last week because it was a rain yesterday. But, the stream along the drainage canal may need to be rehabilitated in order to improve the water-flow in coming summer period. <u>Photos</u> <div style="display: flex; flex-wrap: wrap;"> <div style="width: 50%; text-align: center;">

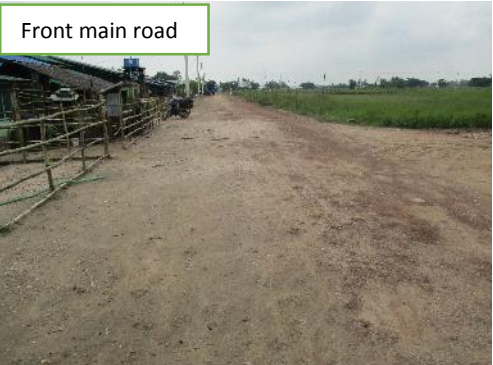
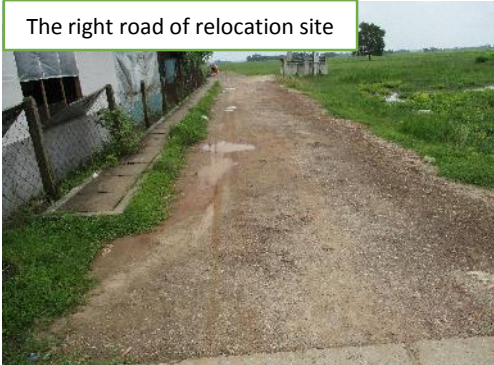
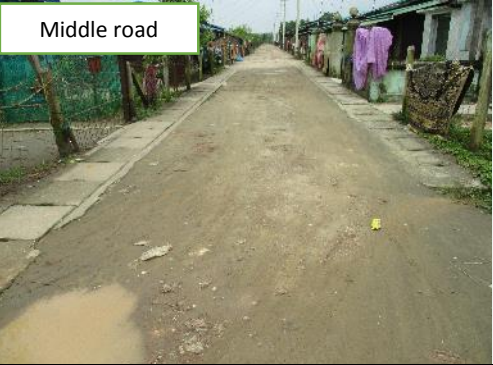
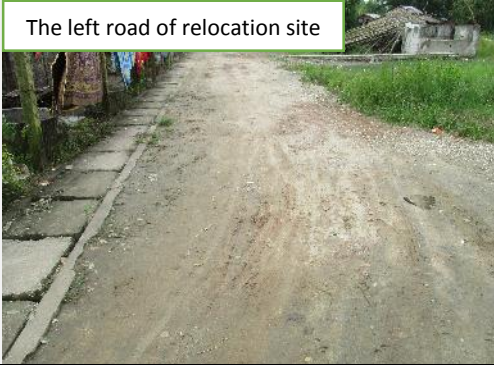
(3). Road	<p>Improved <input type="checkbox"/></p> <p>Same <input checked="" type="checkbox"/>*</p> <p>Worse <input type="checkbox"/></p> <p><i>*as last week</i></p>	<p><u>Description</u></p> <p>-The roads are being wet and muddy in some areas but no problem for walking.</p> <p><u>Photos</u></p>

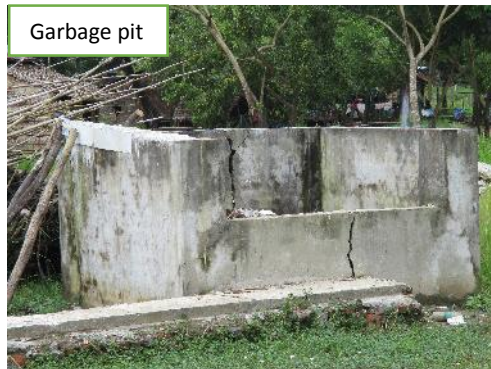
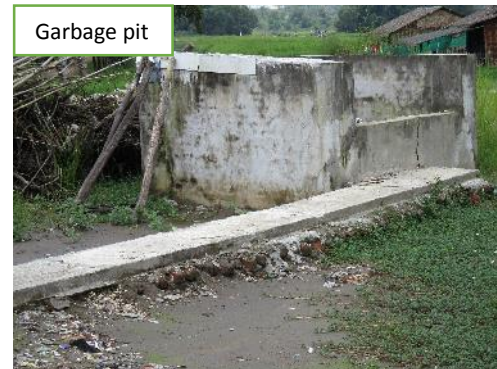
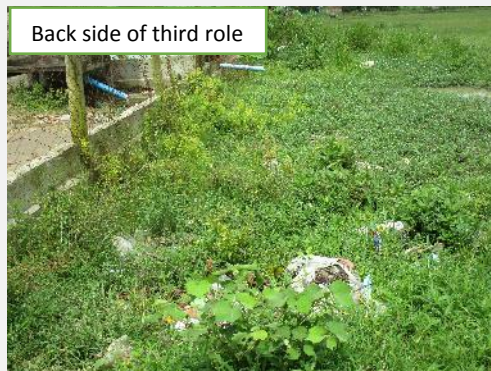
(4). Garbage Condition	<p>Improved <input type="checkbox"/></p> <p>Same <input checked="" type="checkbox"/>*</p> <p>Worse <input type="checkbox"/></p>	<p><u>Description</u></p> <p>-Garbage pit is being used by people.</p> <p>-Garbage pit was cleaned and a new access way to garbage pit had been constructed.</p> <p>-There is no problem for smelling from the garbage pit so far.</p> <p>-People throw garbage at the backside of Third Row and it needs to be collected.</p>

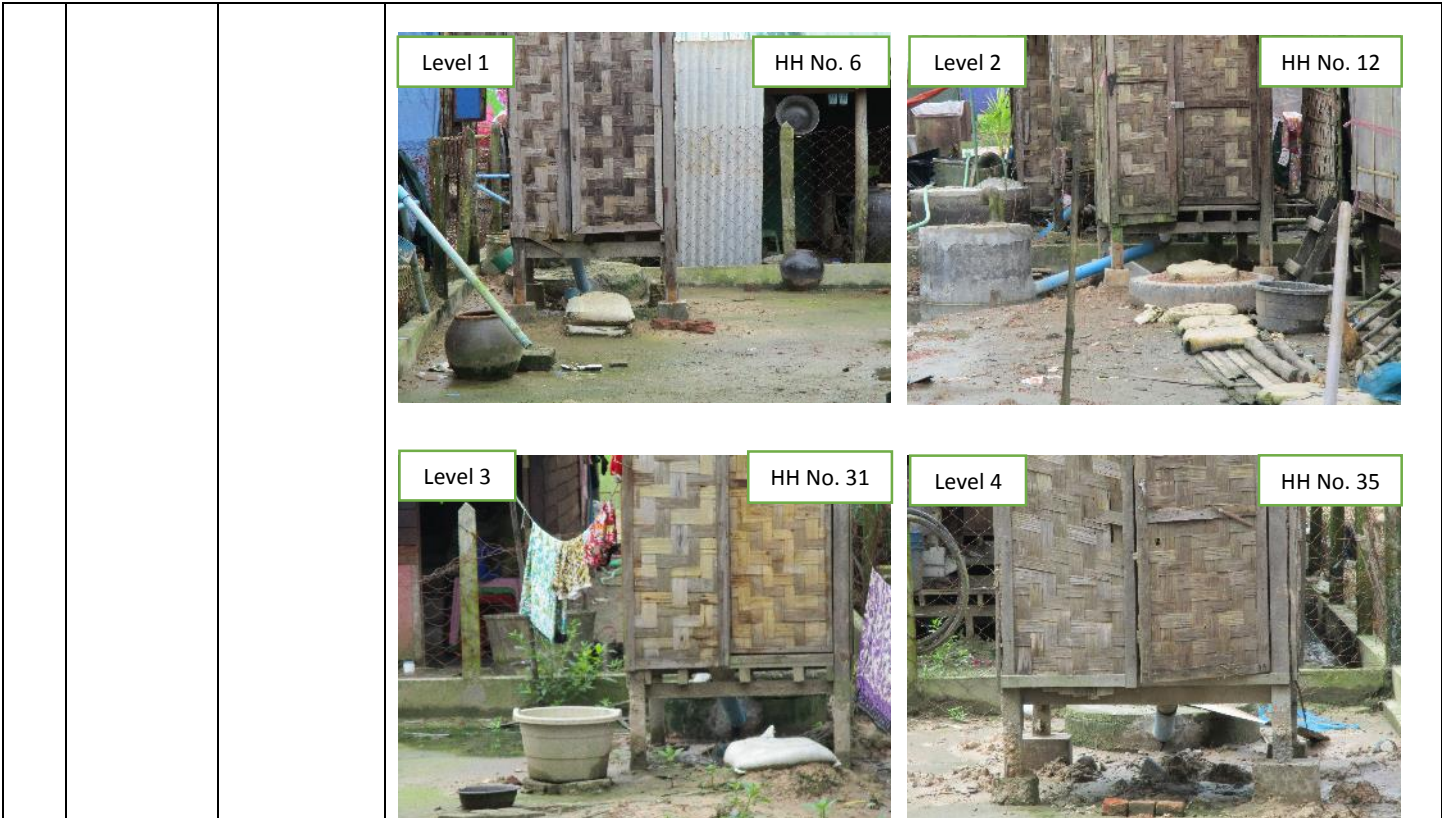
-All of fly proof toilets are used by people.
-Almost all of fly proof toilets made by wood or bamboo have been lifted up as shown in below pictures. Some concrete toilets are still needed to be renovated too as their floors are low and will be inconvenient to use sometimes when there is heavy rain and groundwater level is raised.

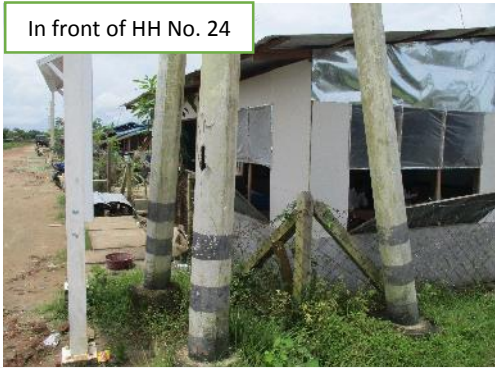
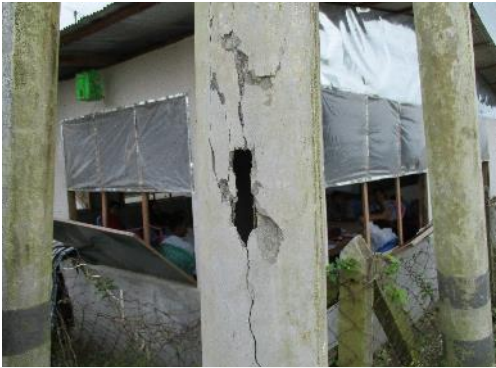
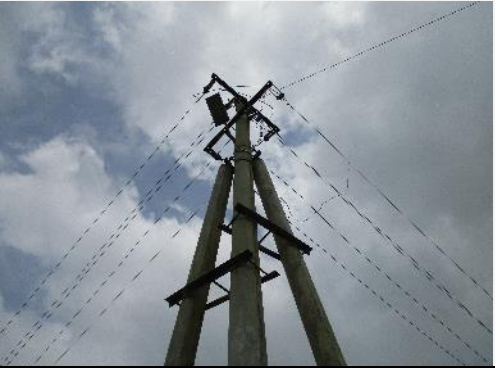
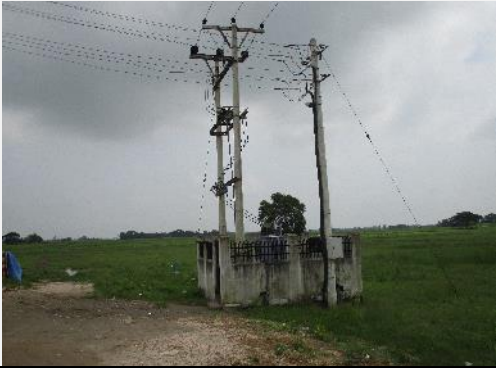
- Electricity comes regularly.
- Electric poles and transformer are being supported with a good foundation.
- But, there is a hole at an electric pole which was hit by a truck car. The electric pole needs to be renovated.

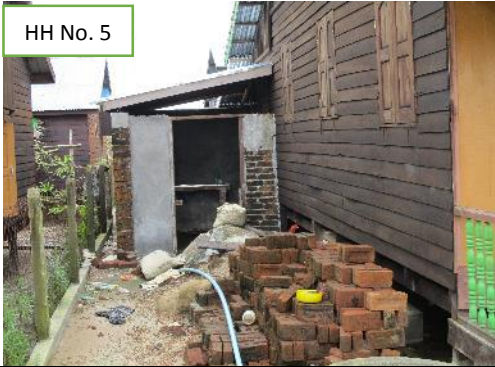
No	Item	Condition	Description and Photos																	
2	House Construction	No. of houses not completed (2)	<p><u>Description</u> -HH No.5, the construction for kitchen, toilet and water tank seems to start again.</p>

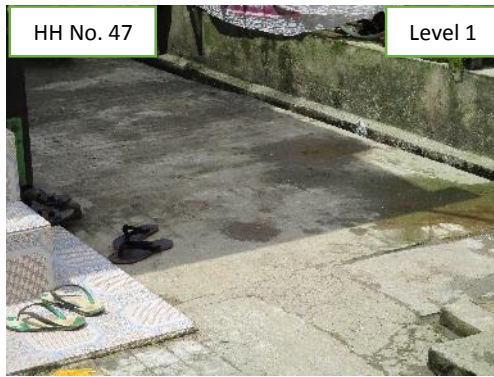
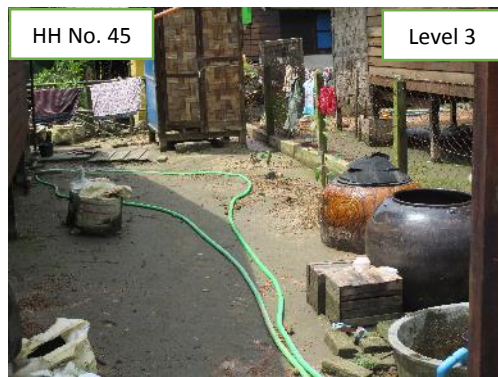
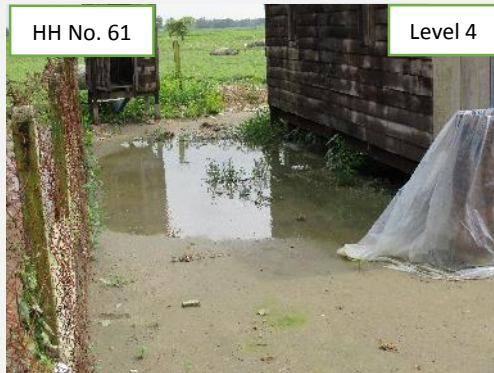
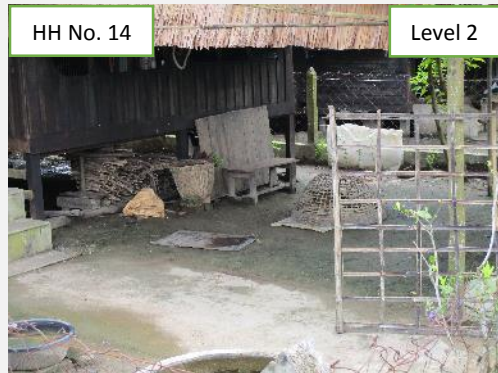
3	Living Status of PAPs (Sold house, renting, etc.)	<p><u>Description</u></p> <p>(1) House ownership (1)-1 No. of house that are owned by PAPs (50) (1)-2 No. of house that were sold (18)</p> <p>(2) Living condition (2)-1 No. of houses where PAPs live (41) (2)-2 No. of houses where original PAPs lives do not live (22) (2)-3 No. of houses where nobody lives (5)</p>	<p>Location Map: See ANNEX.2</p>																	
4	Other issue		<p>(1). Drainage condition for rain water in their compounds</p> <p><u>Description</u> -Rainy season has started. -Some of the compounds are wet.</p>

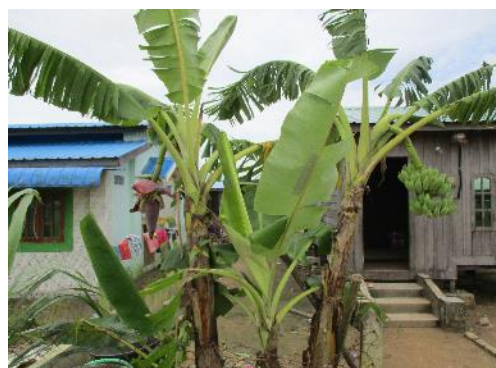
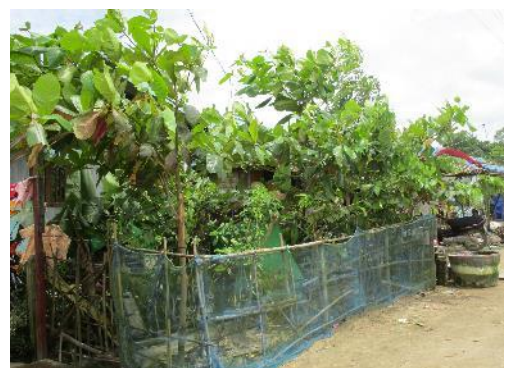
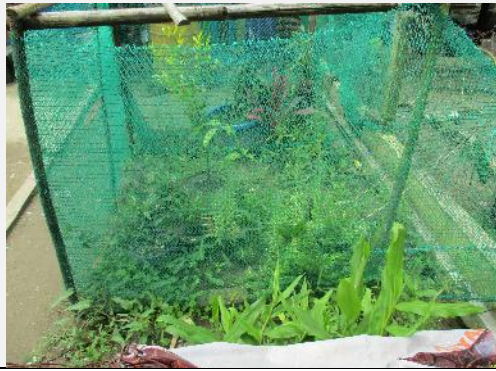
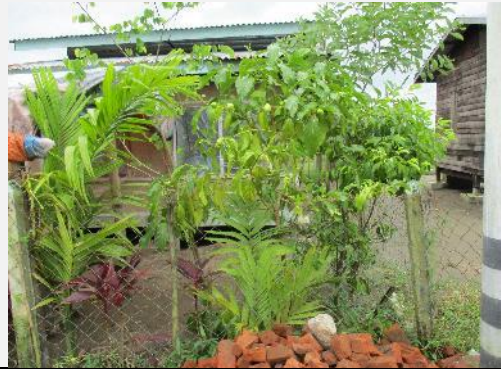
-In front of their compounds, the people planted shady trees, fruit trees, vegetables and floral plants.

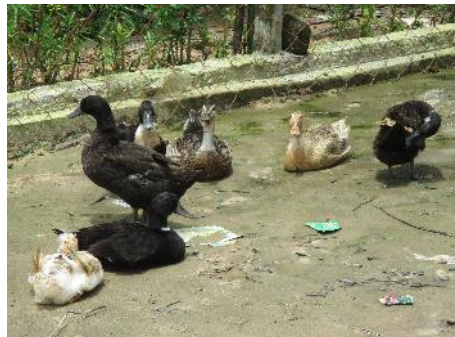
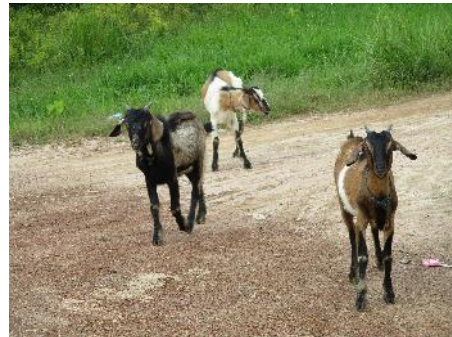
-The people are raising chicken, ducks, goats, pigs and cows.
 -Even though they have cows, some houses do not keep their cows in relocation site instead they keep in their farms or other places.

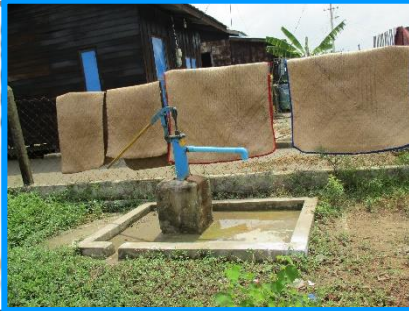
Water is clean and people nearby are using it for drinking and living use . A pulley wheel, bucket and a rope have been set up but the rope seems to be thin and it is better to be changed with thick one for the better use.

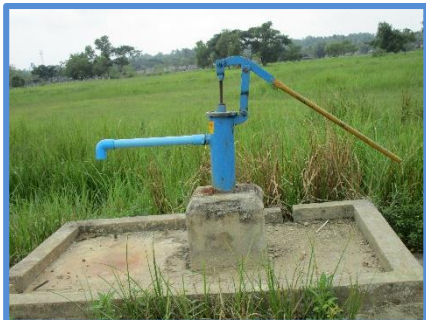
The buffer of the hand pump needs to be change. Therefore, people living nearby are using water from their owned pump or rain water at the moment.

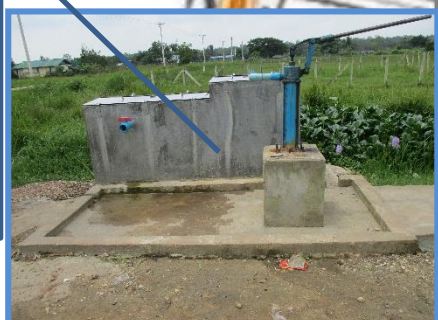
This hand pump is functioned very well. Water is clean and people living nearby are using this hand pump. Moreover water filter tank for remove the smell of iron has been set up beside the hand pump. There is no smell of iron and people enjoy water for drinking and living use.
