Surveyor: Zaw La

Date Visited: 8.9.2015

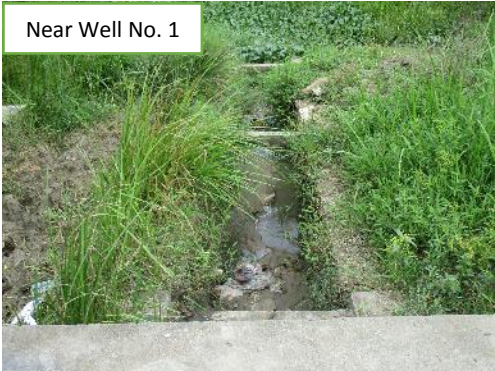
<p>Near Well No. 1</p> </div> <div style="width: 50%; text-align: center;">

(2). Drainage	Improved <input type="checkbox"/> Same <input checked="" type="checkbox"/> * Worse <input type="checkbox"/> <i>*as last week</i>	Description -Water level in the drainage canals is lower than last week because there was a small amount of rain last two days ago. But, the stream along the drainage canal may need to be rehabilitated in order to improve the water-flow in coming summer period.  Photos <div style="display: flex; flex-wrap: wrap;"> <div style="width: 50%; text-align: center;">

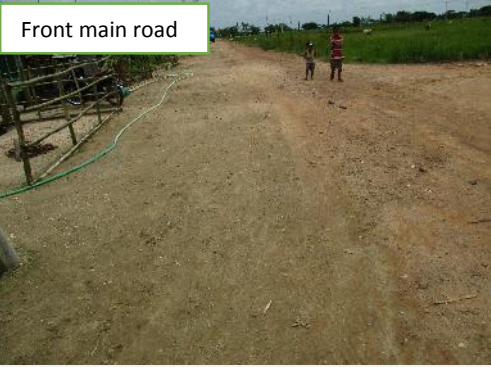
(3). Road	<p>Improved <input type="checkbox"/></p> <p>Same <input checked="" type="checkbox"/>*</p> <p>Worse <input type="checkbox"/></p> <p><i>*as last week</i></p>	<p><u>Description</u></p> <p>-The roads are being wet and muddy in some areas but no problem for walking.</p> <p><u>Photos</u></p>

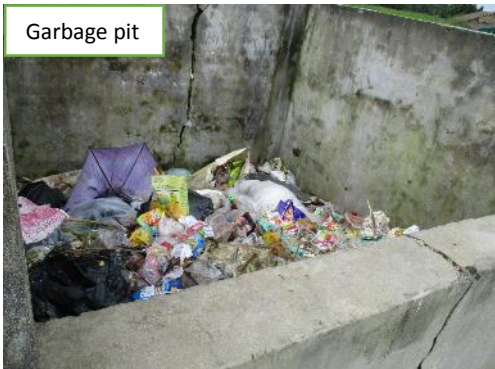
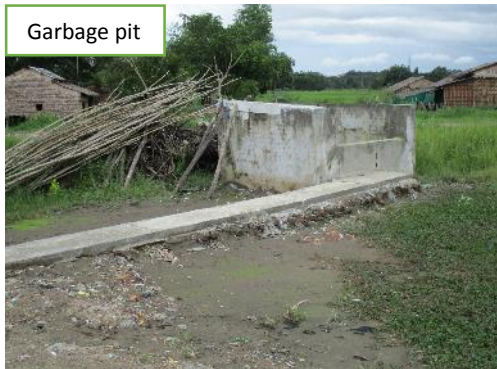
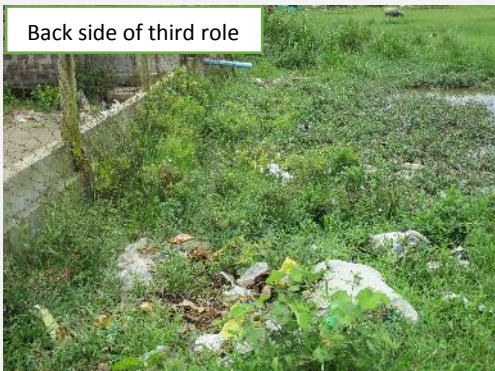
(4). Garbage Condition	<p>Improved <input type="checkbox"/></p> <p>Same <input checked="" type="checkbox"/>*</p> <p>Worse <input type="checkbox"/></p>	<p><u>Description</u></p> <p>-Garbage pit is being used by people.</p> <p>-Garbage pit was cleaned and a new access way to garbage pit had been constructed.</p> <p>-There is no problem for smelling from the garbage pit so far.</p> <p>-People throw garbage at the backside of Third Row and it needs to be collected.</p>

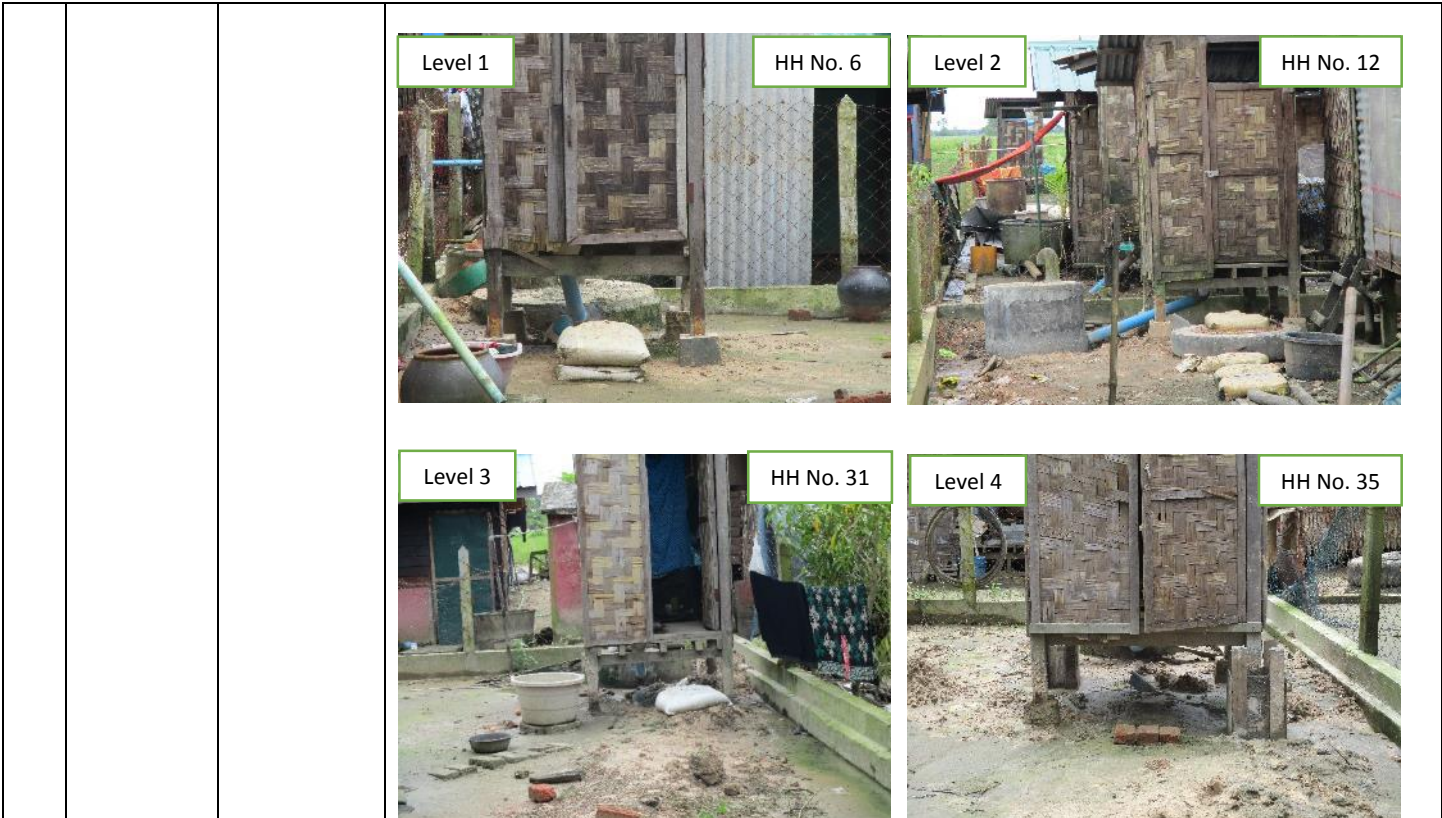
-All of fly proof toilets are used by people.  
-Almost all of fly proof toilets made by wood or bamboo have been lifted up as shown in below pictures. Some concrete toilets are still needed to be renovated too as their floors are low and will be inconvenient to use sometimes when there is heavy rain and groundwater level is raised.

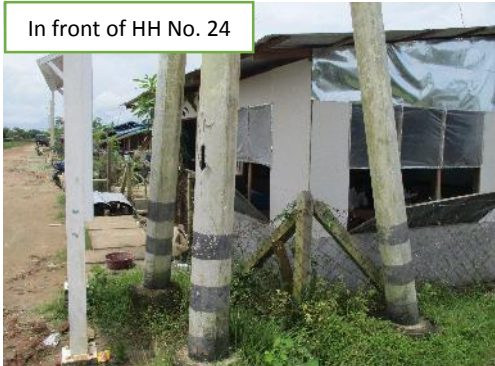
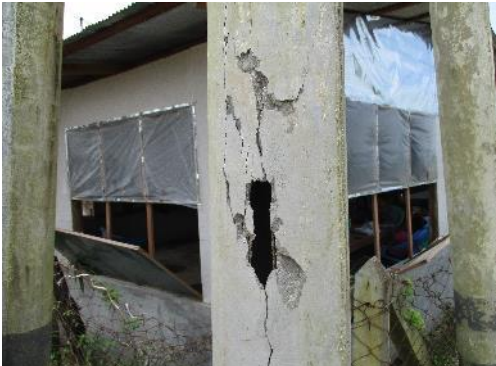
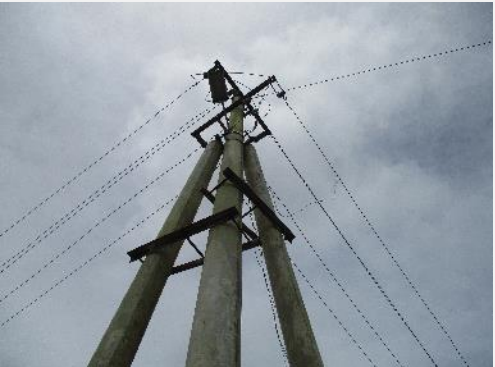
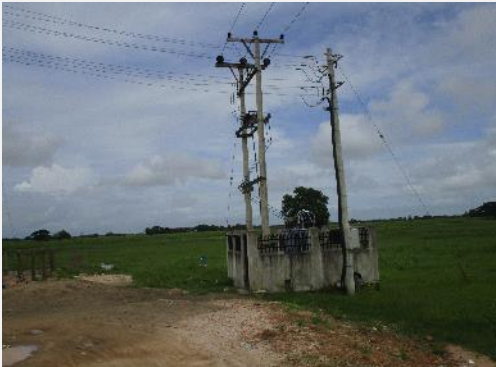
- Electricity comes regularly.
- Electric poles and transformer are being supported with a good foundation.
- But, there is a hole at an electric pole which was hit by a truck car. The electric pole needs to be renovated.

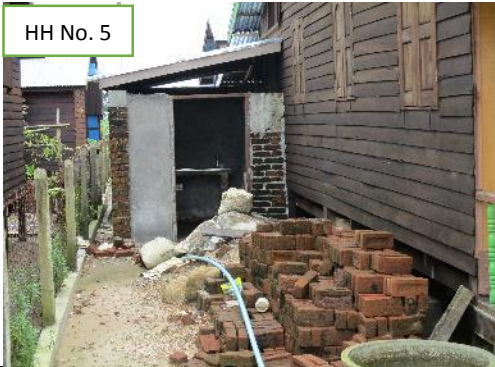
No	Item	Condition	Description and Photos																	
2	House Construction	No. of houses not completed (2)	<p><u>Description</u> -HH No.5, the construction for kitchen, toilet and water tank seems to start again.</p>

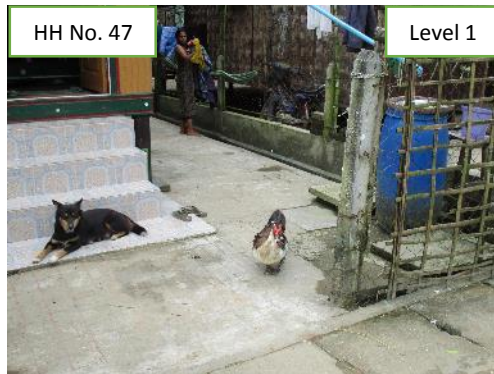
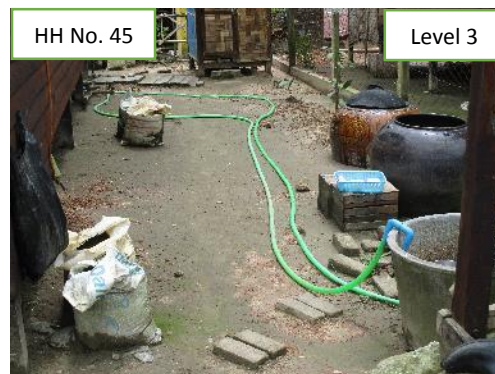
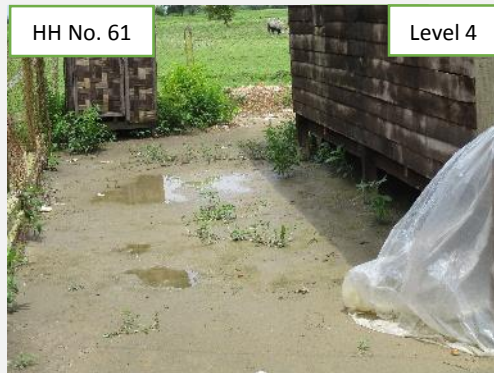
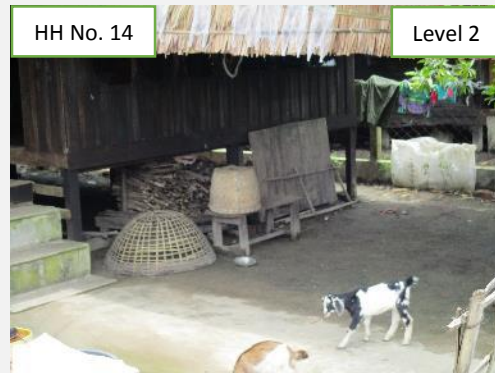
3	Living Status of PAPs (Sold house, renting, etc.)	<p><u>Description</u></p> <p>(1) House ownership  (1)-1 No. of house that are owned by PAPs (50)  (1)-2 No. of house that were sold (18)</p> <p>(2) Living condition  (2)-1 No. of houses where PAPs live (41)  (2)-2 No. of houses where original PAPs lives do not live (22)  (2)-3 No. of houses where nobody lives (5)</p>	<p>Location Map: See ANNEX.2</p>																	
4	Other issue		<p>(1). Drainage condition for rain water in their compounds</p> <p><u>Description</u> -Rainy season has started. -Some of the compounds are wet.</p>

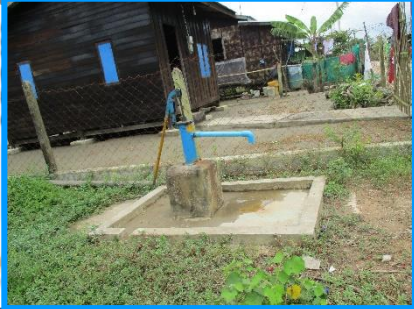
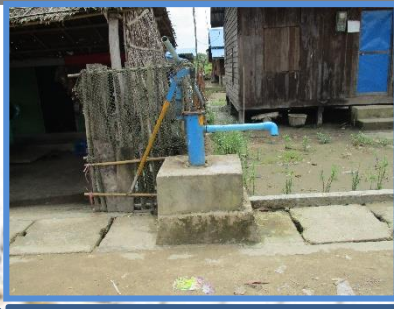
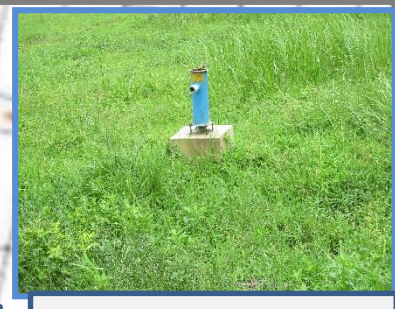
Water is clean and people nearby are using it for drinking and living use . A pulley wheel, bucket and a rope have been set up but the rope seems to be thin and it is better to be changed with thick one for the better use.

Hand pump isn't functioned.

This hand pump is functioned very well. Water is clean and everyone nearby using this hand pump for drinking water and living use.

As the buffer has been changed with the new one and the hand pump is functioned very well now. Water is also clean and people living nearby use it for drinking and living use again.

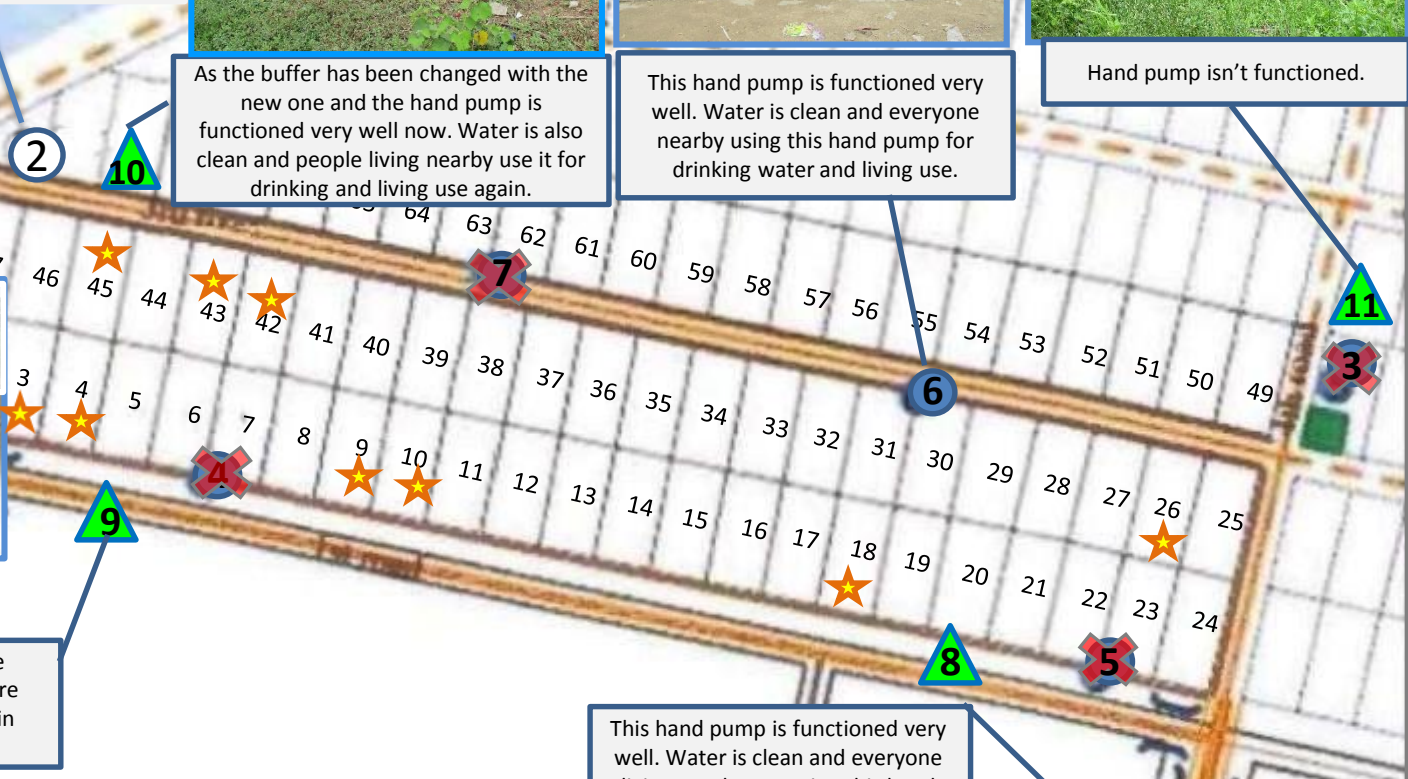
This well cannot be used as water is dirty. A pulley wheel, bucket and a rope have been set up but the rope seems to be thin and it is better to be changed with a thick one for the better use.

The buffer of the hand pump needs to be change. Therefore, people living nearby are using water from their owned pump or rain water at the moment.

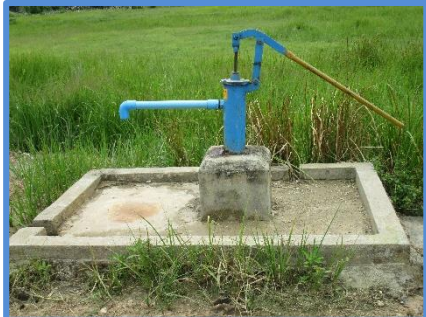
This hand pump is functioned very well. Water is clean and everyone living nearby are using this hand pump. Moreover water filter tank for remove the smell of iron has been set up beside the hand pump. There is no smell of iron and people enjoy water for drinking and living use.
