Surveyor: Zaw La

Date Visited: 24.8.2015

No	Item	Condition	Description and Photos
1	Condition of -		
	(1). Well	Improved <input type="checkbox"/> Same <input checked="" type="checkbox"/> * Worse <input type="checkbox"/> <i>*as last week</i>	Description & Photos: -See ANNEX.1 - Both of the two open wells are dirty. It seems that muddy groundwater is passing through the crack at the wall of the well. Compared with last week, well no. 1 is gradually clean this week and used by surrounding people again. In terms of avoiding the muddy water under the ground, both open wells need to be renovated again in summer. The buffers of some hand pumps need to be changed, but people get water from their own well or rain water currently.

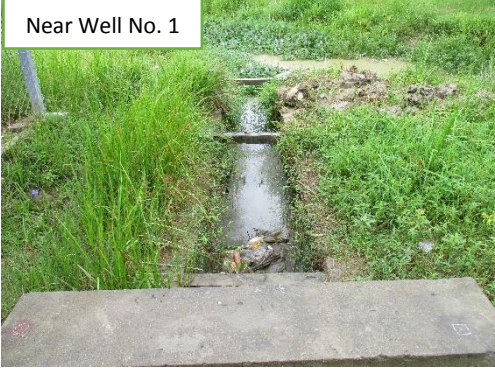
<p>Near Well No. 1</p> </div> <div style="width: 50%; text-align: center;">

(2). Drainage	Improved <input type="checkbox"/> Same <input checked="" type="checkbox"/> * Worse <input type="checkbox"/> <i>*as last week</i>	Description -Water level in the drainage canals is lower than last week because there was a small amount of rain last night. But, the stream along the drainage canal may need to be rehabilitated in order to improve the water-flow in coming summer period. Photos <div style="display: flex; flex-wrap: wrap;"> <div style="width: 50%; text-align: center;">

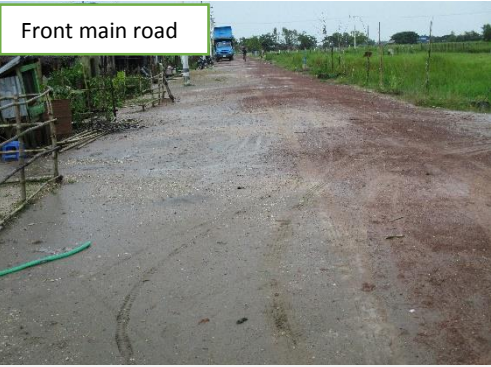
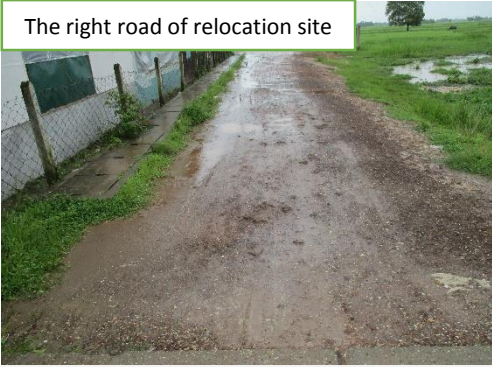
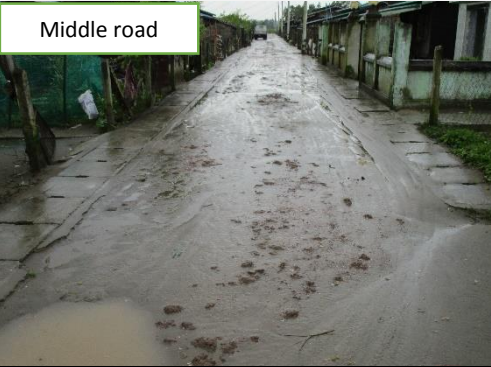
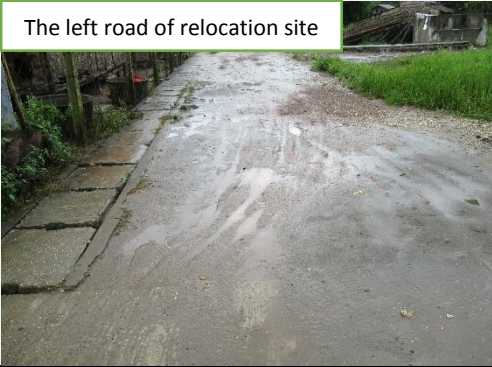
(3). Road	<p>Improved <input type="checkbox"/></p> <p>Same <input checked="" type="checkbox"/>*</p> <p>Worse <input type="checkbox"/></p> <p><i>*as last week</i></p>		<p><u>Description</u> -The roads are being wet and muddy in some areas but no problem for walking.</p> <p><u>Photos</u></p> <div style="display: flex; flex-wrap: wrap;"> <div style="width: 50%;">

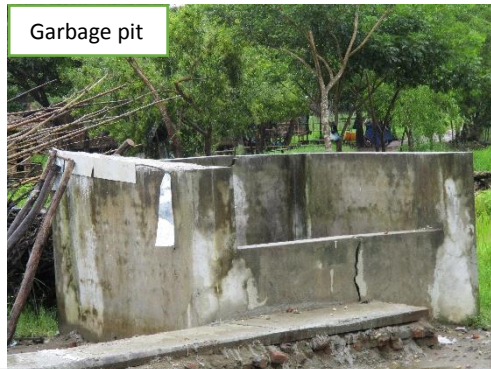
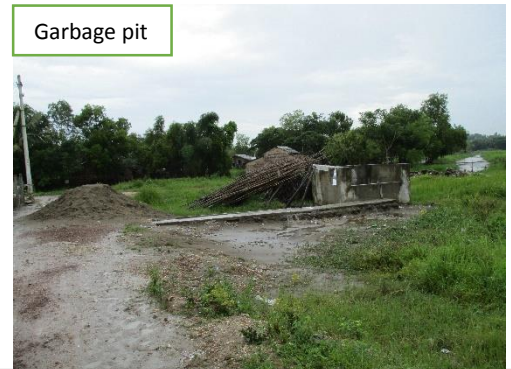
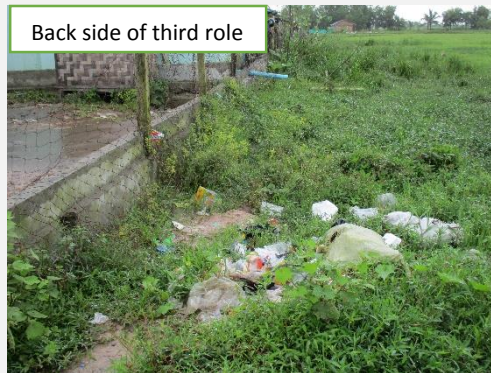
(4). Garbage Condition	<p>Improved <input type="checkbox"/></p> <p>Same <input checked="" type="checkbox"/>*</p> <p>Worse <input type="checkbox"/></p>		<p><u>Description</u> -Garbage pit is being used by people. -Garbage pit was cleaned and a new access way to garbage pit had been constructed. -There is no problem for smelling from the garbage pit so far. -People throw garbage at the backside of Third Row and it need to be collected.</p>

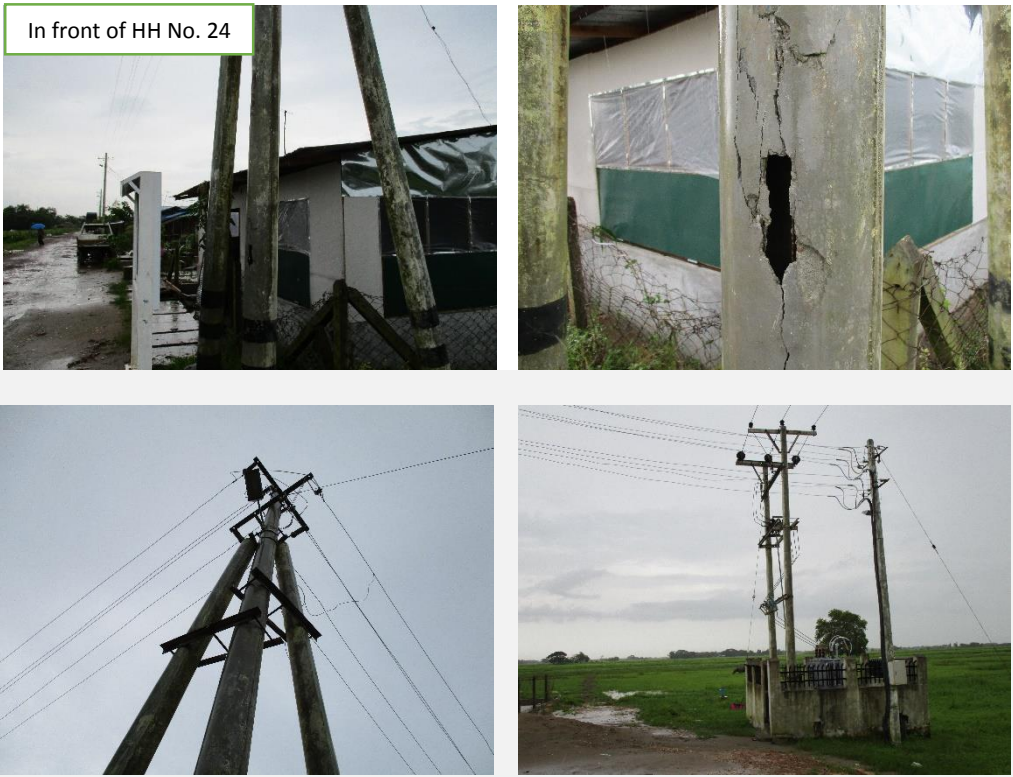
-Electricity comes regularly.
 -Electric poles and transformer are being supported with a good foundation.
 -But, there is a hole at an electric pole which was hit by a truck car. The electric pole needs to be renovated.

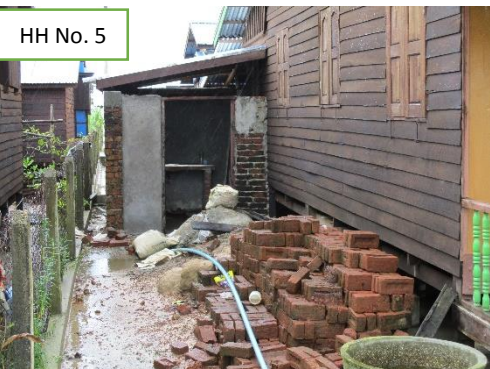
No	Item	Condition	Description and Photos																	
2	House Construct-ion	No. of houses not completed (2)	<p><u>Description</u></p> <p>-HH No.5, the construction for kitchen, toilet and water tank seems to be started again.</p>

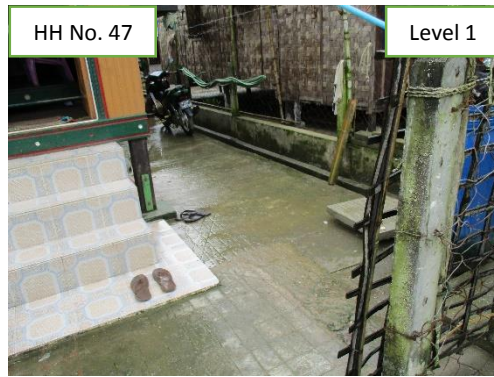
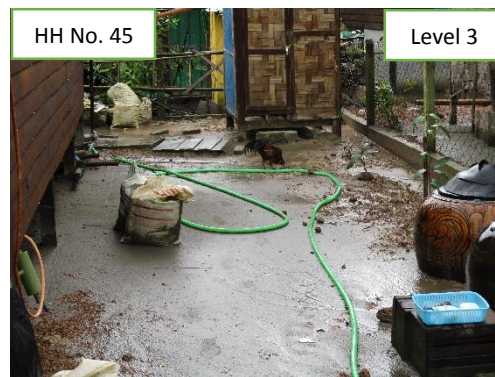
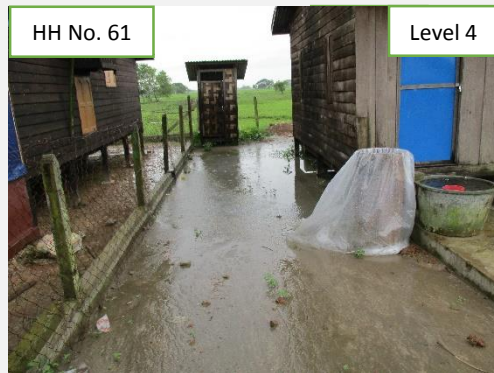
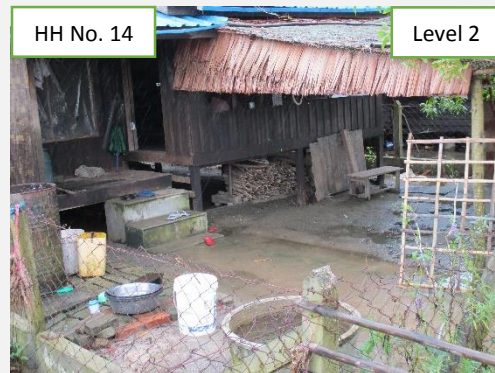
3	Living Status of PAPs (Sold house, renting, etc.)	<p><u>Description</u></p> <p>(1) House ownership</p> <p>(1)-1 No. of house that are owned by PAPs (50)</p> <p>(1)-2 No. of house that were sold (18)</p> <p>(2) Living condition</p> <p>(2)-1 No. of houses where PAPs live (41)</p> <p>(2)-2 No. of houses where original PAPs lives do not live (22)</p> <p>(2)-3 No. of houses where nobody lives (5)</p>	<p>Location Map: See ANNEX.2</p>																	
4	Other issue		<p>(1). Drainage condition for rain water in their compounds</p> <p><u>Description</u></p> <p>-Rainy season has been started.</p> <p>-Most of the compounds are wet.</p>

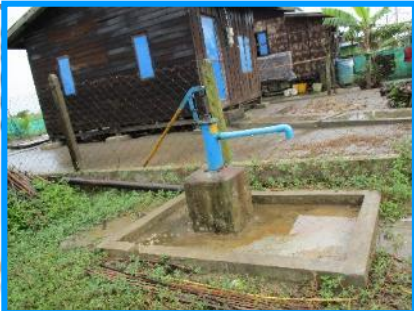
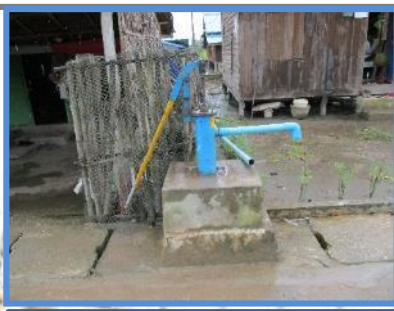
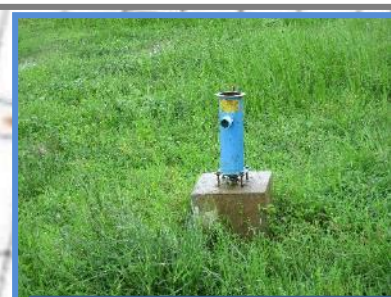
Water is clean and people nearby are using it for drinking and living use. A pulley wheel, bucket and a rope have been set up but the rope seems to be thin and it is better to be changed with thick one for the better use.

As the buffer has been changed with the new one and the hand pump is functioned very well now. Water is also clean and people nearby are using it for drinking and living use again.

This hand pump is functioned very well. Water is clean and everyone nearby using this hand pump for drinking water and living use.

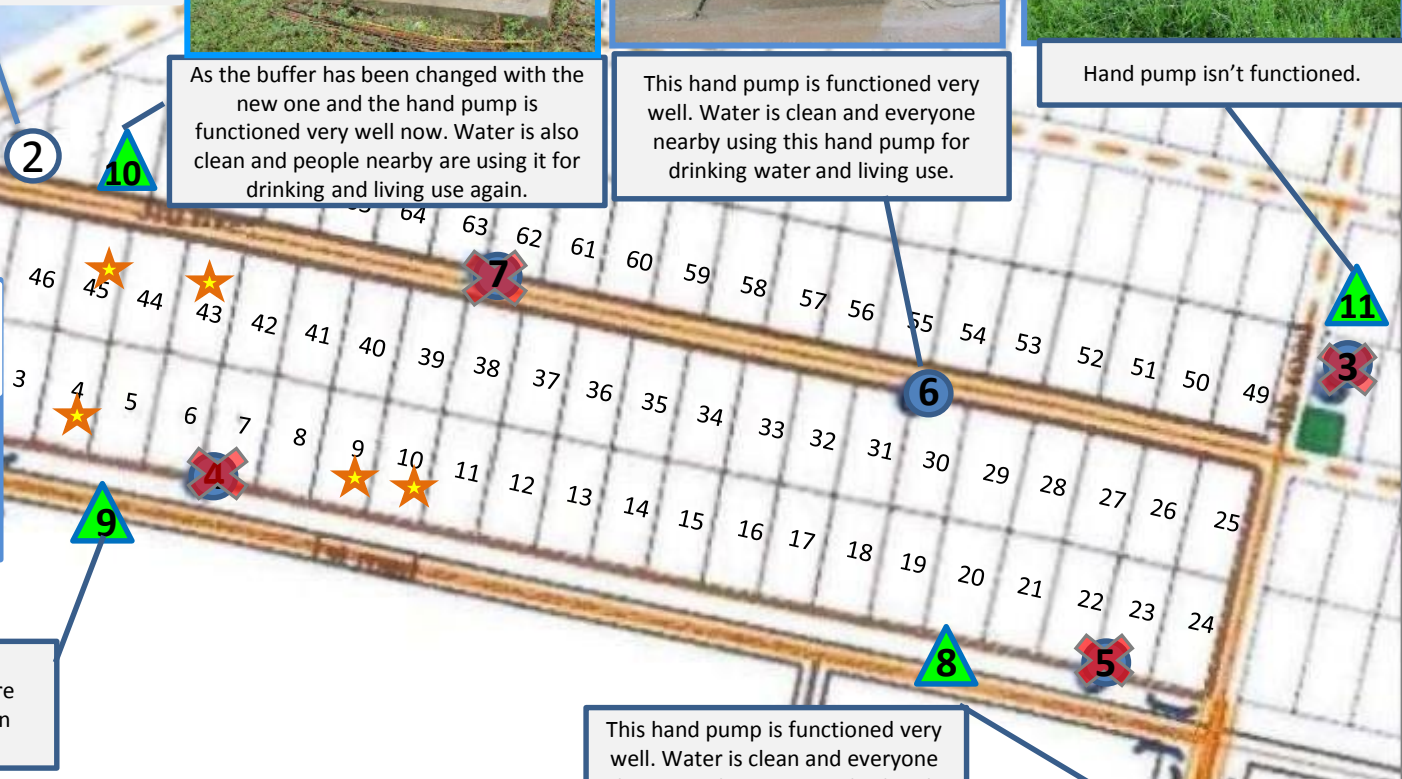
- Closed Well
- New Well (Hand pump)
- Open Well
- Hand Pump
- Private Well

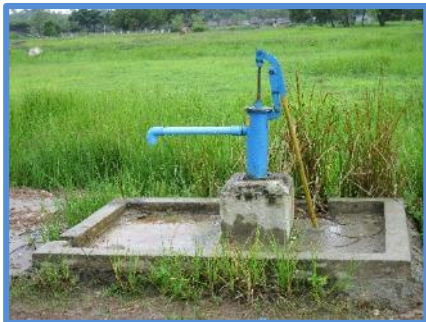
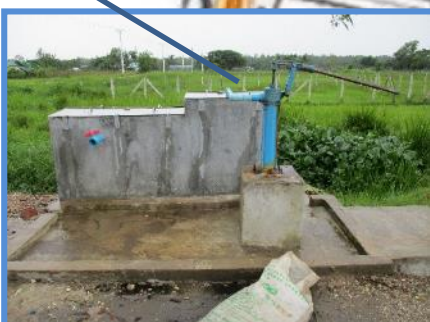
Hand pump isn't functioned.

This well cannot be used as water is dirty. A pulley wheel, bucket and a rope have been set up but the rope seems to be thin and it is better to be changed with a thick one for the better use.

The buffer of the hand pump needs to be change. Therefore, people living nearby are using water from their owned pump or rain water at the moment.

This hand pump is functioned very well. Water is clean and everyone living nearby are using this hand pump. Moreover water filter tank for remove the smell of iron has been set up beside the hand pump. There is no smell of iron and people enjoy water for drinking and living use.
