**Bi weekly Field Report**

**No. 24**

Surveyor Zaw La  
 Date visited 13 Sep 2018  
 Time visited 10:30 am

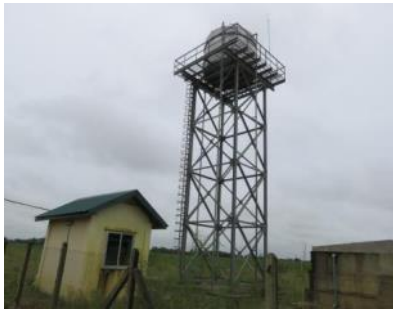
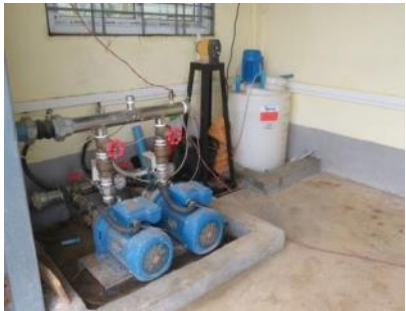
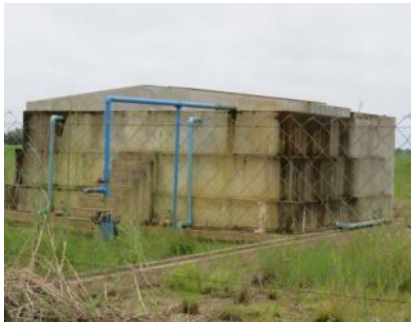
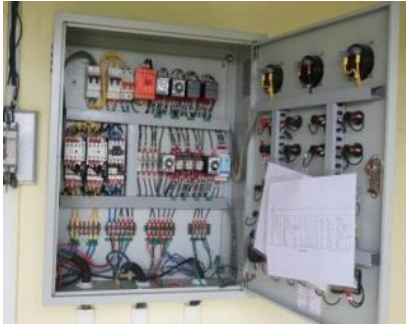
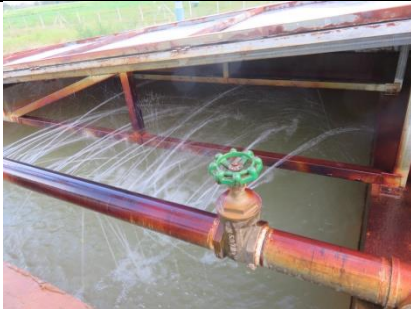
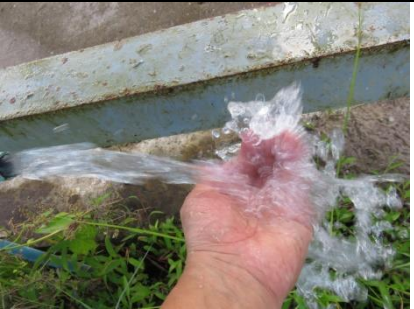
No	Item	Condition	Narrative Description and Photos	
1	(1.1) Water Supply System	Improved <input type="checkbox"/> Same <input checked="" type="checkbox"/> * Worse <input type="checkbox"/> *as last week	<p><b><u>Narrative Description</u></b></p> <p>Water distribution system has been supporting ninety household of the zone B resettled families. Among many parts of the system, the ground tank need to do cleaning around once in twice month basic because the underground water includes iron hydroxide and yellowish mud that clogged in the iron removal tank.</p> <p><b><u>Photos</u></b></p>

<p>Water from ground water tank</p>	<p>Pipe line distribution water to houses</p>

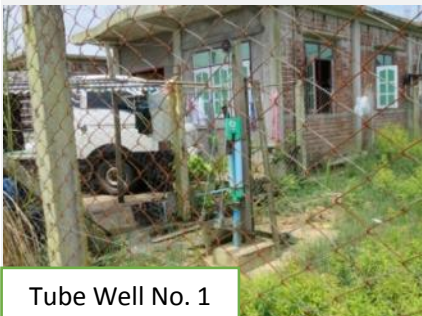
<p data-bbox="560 1106 984 1128">Tube Well No. 1</p>

No	Item	Condition	Narrative Description and Photos	
1	(1.2) Well	Improved <input type="checkbox"/> Same <input checked="" type="checkbox"/> * Worse <input type="checkbox"/> <i>*as last week</i>	<p>– Water from two open-wells is clean enough to use for drinking and living. There are eleven tube wells in the relocation site. Residents use the water basically from the pipeline distribution system so that the usage from the tube wells is quiet low. However, JET asked to inform if the tube wells are needed to repair.</p>	
			  <p data-bbox="560 719 984 770">Open Well No. 1</p>	  <p data-bbox="1007 719 1444 770">Open Well No. 2</p>

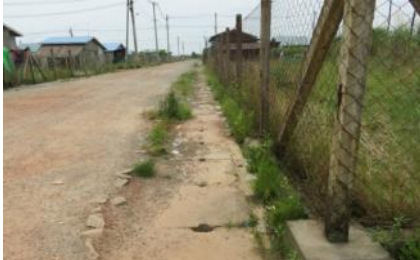
<p>The drain at the corner of Main Road A and B</p>

<p>Tube Well No.7</p>
(2) Drainage	Improved <input type="checkbox"/> Same <input checked="" type="checkbox"/> * Worse <input type="checkbox"/> <i>*as last week</i>	<p>– There is a little amount of water in the drainage canals at the moment.</p> <p><b>Photos</b></p>

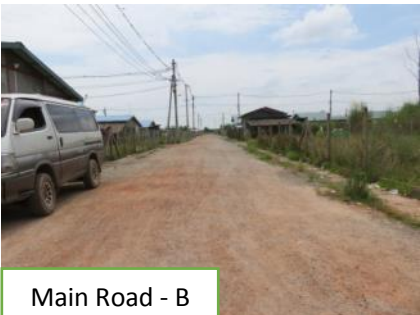
<p>Main Road - B</p>

(3) Road	Improved <input type="checkbox"/> Same <input checked="" type="checkbox"/> * Worse <input type="checkbox"/> <i>*as last week</i>	<p>– All the roads are getting wet but no problem for walking except from road no. 1 where some mud are deposited and it is needed to be careful to walk across on it.</p> <p><b>Photos</b></p>

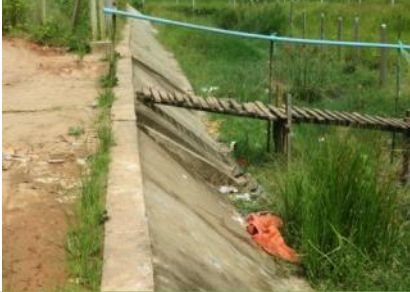
(4) Garbage Condition	Improved <input type="checkbox"/> Same <input checked="" type="checkbox"/> * Worse <input type="checkbox"/> <i>*as last week</i>	<ul style="list-style-type: none"> <li>- The rubbishes have been dumped beside the creek and even in front of the houses before the enough garbage bins are provided.</li> <li>- Total of fourteen garbage bins have been provided and placed at the corner of each road until the end of April. In the meantime, all the garbage bins are kept by the community leader of PAPs in the communal compound near the triangle junction of Main Road C and Upper Fourth Street. So, the garbage will be kept in the house until the garbage truck comes and collects during the raining season.</li> </ul> <p><b>Photos</b></p>
			<div style="display: flex; justify-content: space-around;"> <div style="text-align: center;">

<p>Rubbishes in the creek near 1st street</p> </div> <div style="text-align: center;">

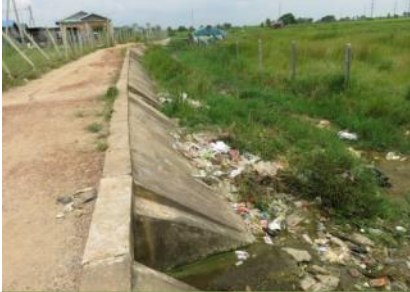
<p>Rubbishes in the creek near 2nd street</p> </div> </div>

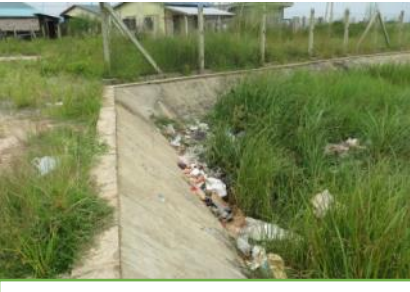
<p>Rubbishes in the creek near Main Road C</p> </div> <div style="text-align: center;">

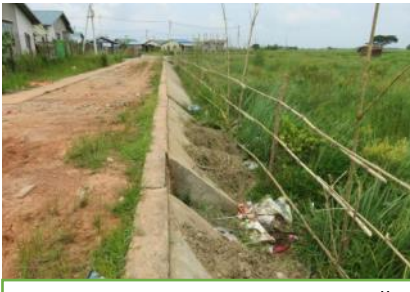
<p>Rubbishes in the creek near 6<sup>th</sup> Street</p> </div> </div>

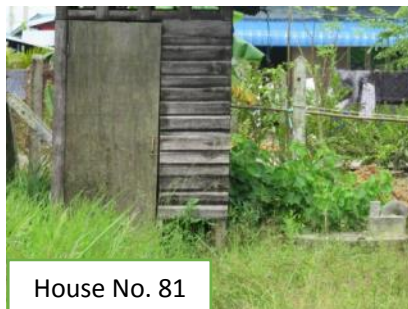
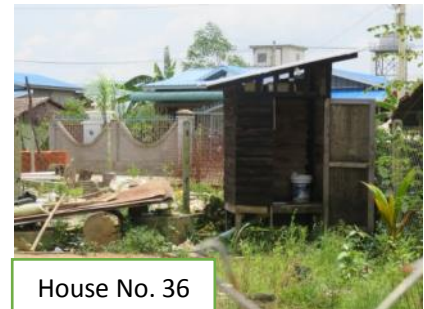
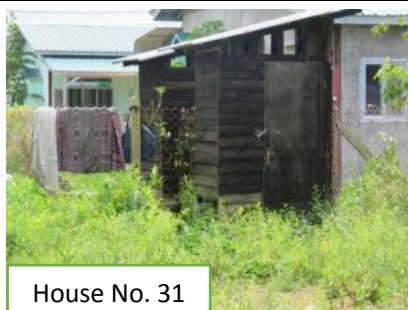
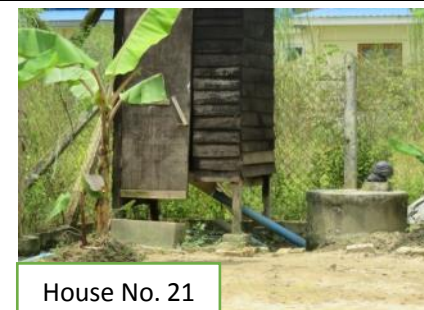
- All of the fly proof toilets are used the residents.
- All of the toilets are repaired by the following procedures;
  - Installation the extra septic tanks beside the original
  - The pipe line system is installed from the extra tank to the ditch to flow the liquid out.

The toilet renovation plan was successfully done and there is no problem at the moment.

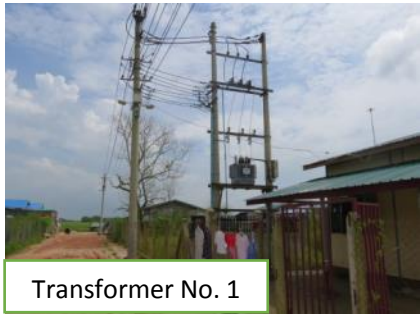
<p>Transformer No. 1</p>

(6) Electricity	Improved <input type="checkbox"/> Same <input checked="" type="checkbox"/> * Worse <input type="checkbox"/> <i>*as last week</i>	<ul style="list-style-type: none"> <li>– Residents get the electricity regularly.</li> <li>– Electric poles and transformer are being supported with the good foundations.</li> <li>– There are some pieces of wood under an electric pole of main road B and it's needed to clean up.</li> </ul> <p><b>Photos</b></p>

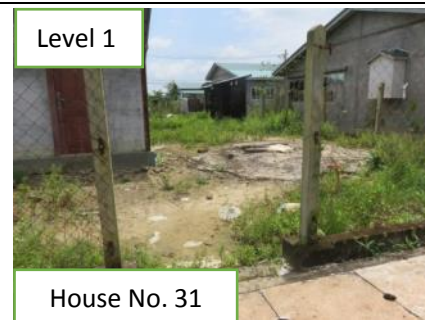
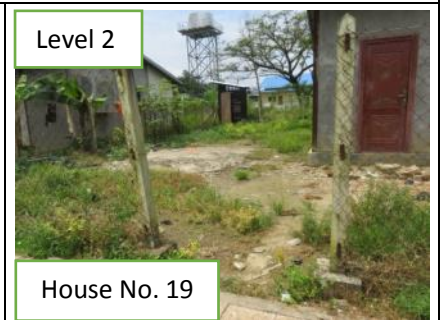
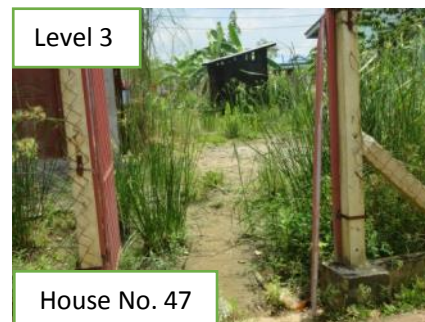
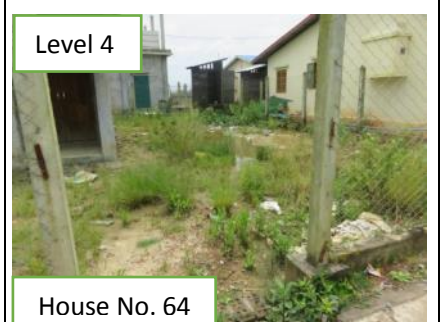
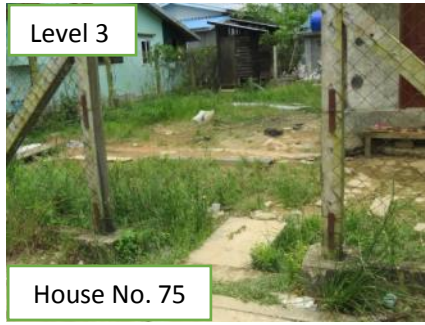
Condition	No. of HHs	
	This week condition	Previous week condition
Level 1	85	85
Level 2	3	3
Level 3	2	2
Level 4	1	1
