Surveyor: Zaw La
 Date Visited: 14.12.2015
 Time Visited: 11:35 to 12:25

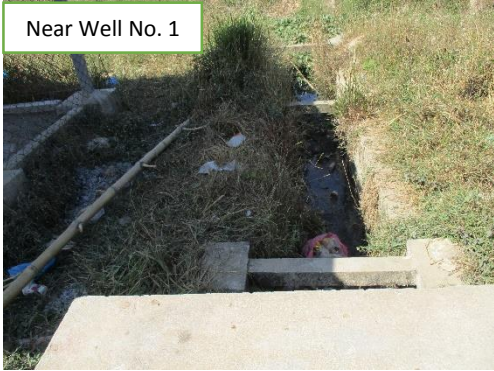
(2). <u>Drainage</u>	Improved <input type="checkbox"/> Same <input checked="" type="checkbox"/> * Worse <input type="checkbox"/> <i>*as last week</i>	<u>Description</u> -Water level in the drainage canals are decreased than last week because there was no rain. The stream along the drainage canal may need to be rehabilitated in coming summer period in order to improve the water-flow along the stream. <u>Photos</u> <div style="display: flex; flex-wrap: wrap;"> <div style="width: 50%; text-align: center;"> <p>Near Well No. 1</p>

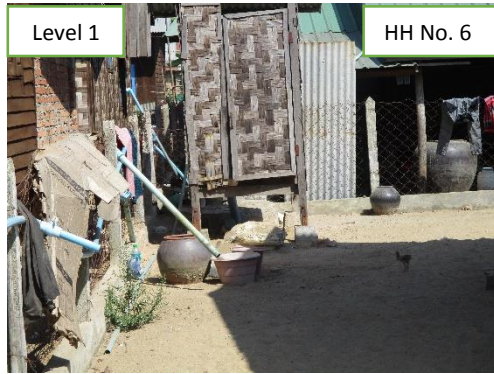
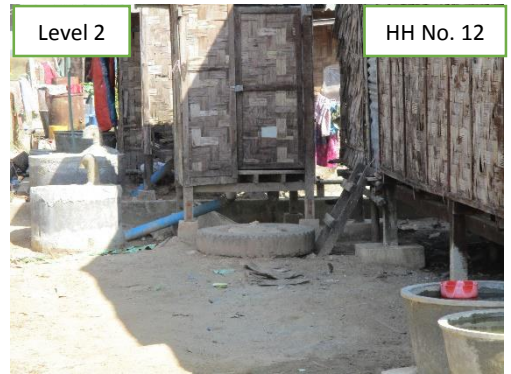
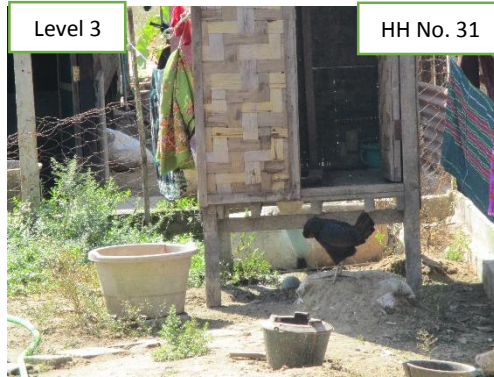
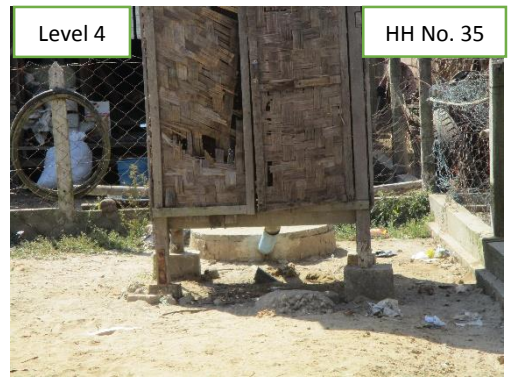
-All of fly proof toilets are used by people.
-Almost all of fly proof toilets made by wood or bamboo have been lifted up as shown in pictures below and are convenient to use. Some concrete toilets are still need to be renovated. According to discussion with community people, they would like to repair concrete toilets by themselves and requested for financial support. JET had already paid for it.

-After filling the soil, some toilets need to be lifted up.

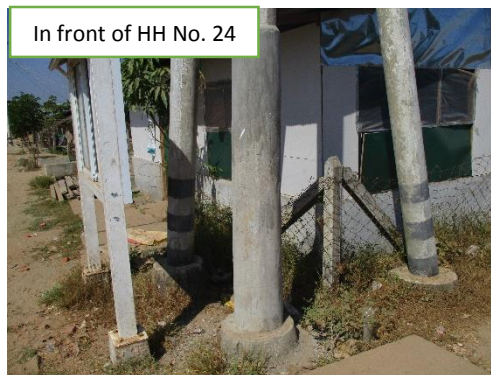
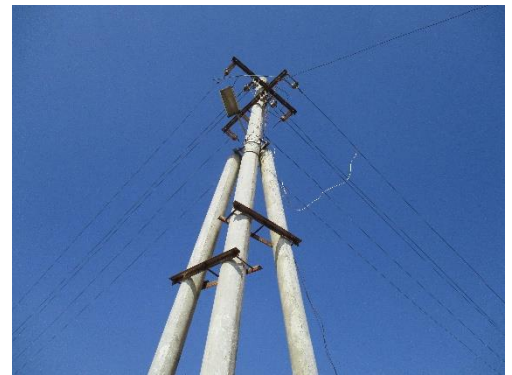
Photos

- Electricity comes regularly.
- Electric poles and transformer are being supported with a good foundation.
- There was a hole at an electric pole which was hit by a truck car, but the electric pole was renovated.

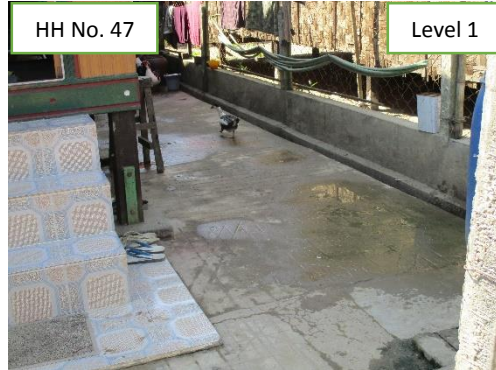
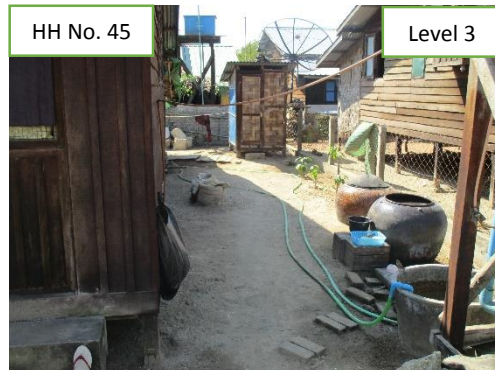
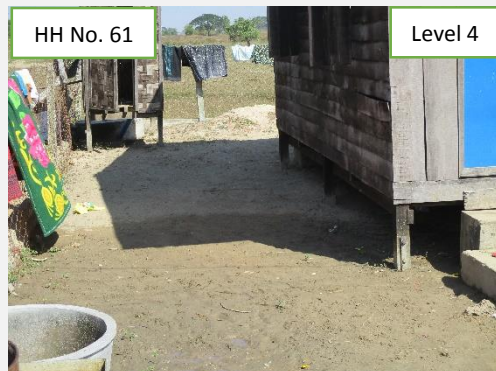
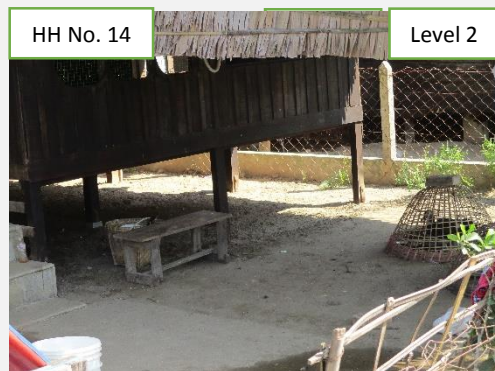
Photos

4	Other issue	Description																	
	(1). Drainage condition for rain water in their compounds	<p>-Rainy season has started. -Some of the compounds are wet.</p>

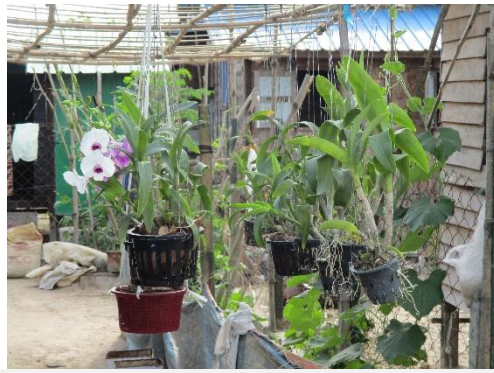
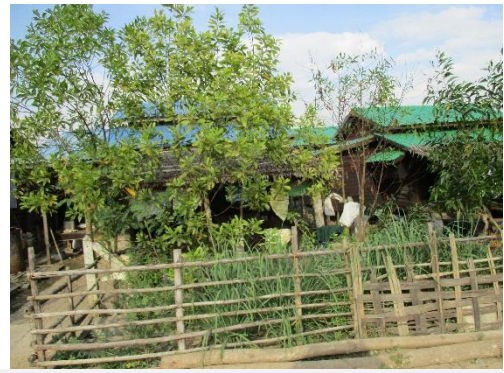
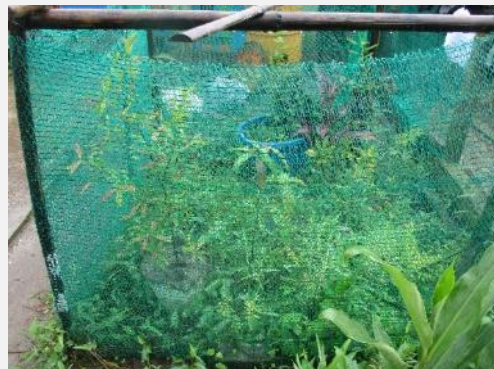
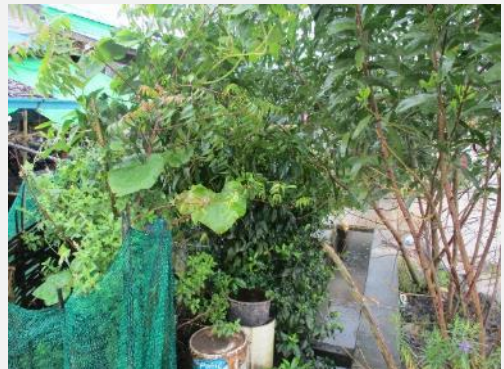
-In front of their compounds, the people planted shady trees, fruit trees, vegetables and floral plants.

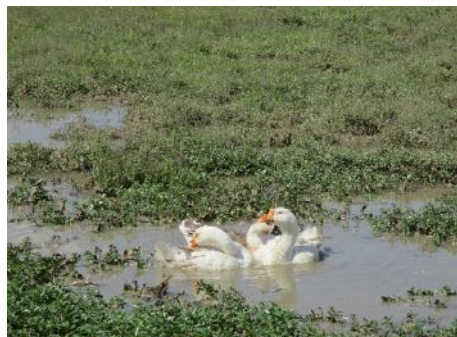
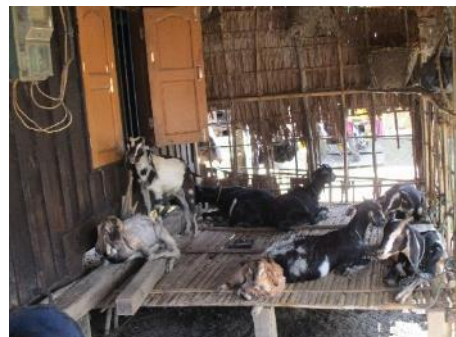
Photos

-The people are raising chicken, ducks, goats and cows.
 -Even though they have cows, some PAPs do not keep their cows in relocation site instead they keep in their farms or other places.
