Surveyor: Zaw La

Date Visited: 19.8.2015

| No | Item | Condition | Description and Photos |

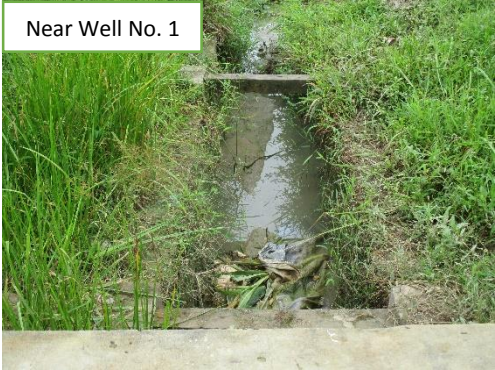
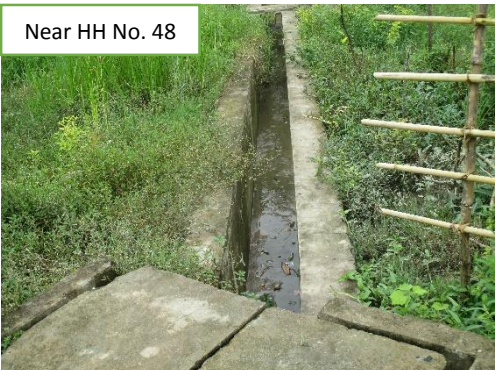
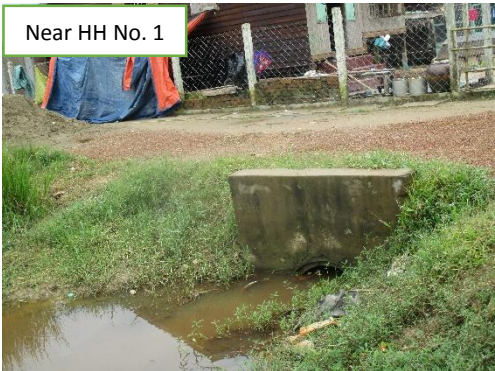
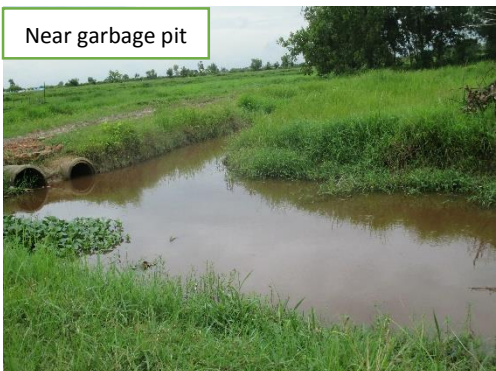
| No | Item | Condition | Description and Photos |
|---|---|---|---|
| | (2). <u>Drainage</u> | Improved <input type="checkbox"/> Same <input checked="" type="checkbox"/> * Worse <input type="checkbox"/> <i>*as last week</i> | <u>Description</u> -Water level in the drainage canals lower than last week because there was only a little rain last night. But, the stream along the drainage canal may needs to be rehabilitated in next summer. <u>Photos</u> <div style="display: flex; flex-wrap: wrap;"> <div style="width: 50%; text-align: center;"> <p>Near Well No. 1</p> </div> <div style="width: 50%; text-align: center;"> <p>Near HH No. 48</p> </div> <div style="width: 50%; text-align: center;"> <p>Near HH No. 1</p> </div> <div style="width: 50%; text-align: center;"> <p>Near garbage pit</p> </div> </div> |

| | | | <p>In front of HH No. 1</p> |

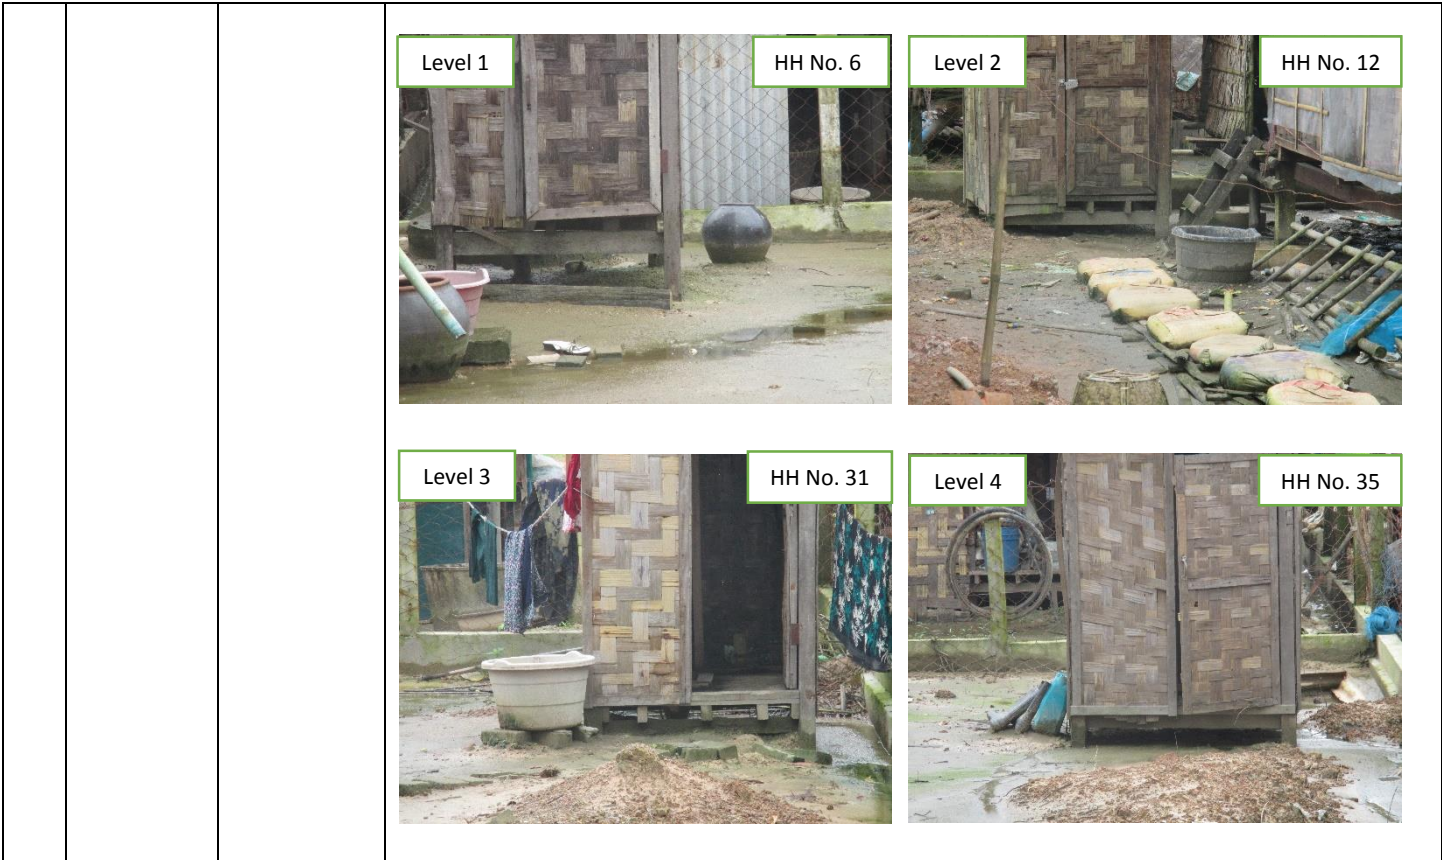
Item
(5). Fly
proof
toilet

-All of fly proof toilets are used by people.

- Need to repair fly proof toilet
- Often toilet unavailable
- As the result of filling the soil and also raining, some toilets are inconvenience to use.

- Need to repair urgently fly proof toilet
- Often toilet unavailable
- After filling the soil, some toilets need to be lifted up.

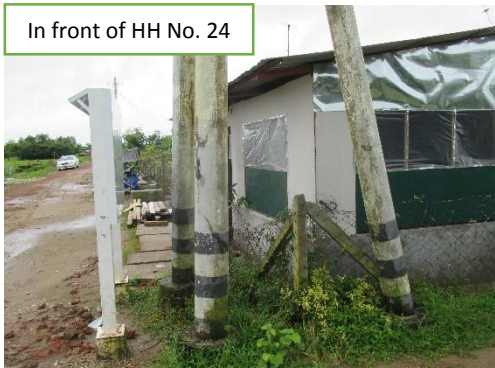
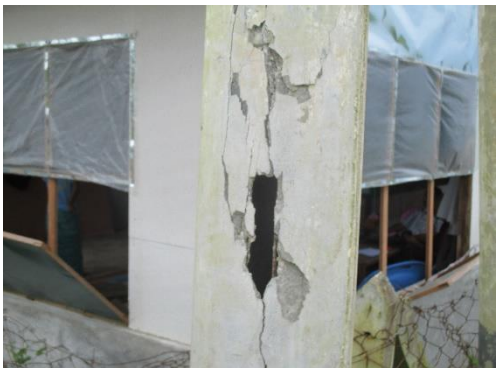
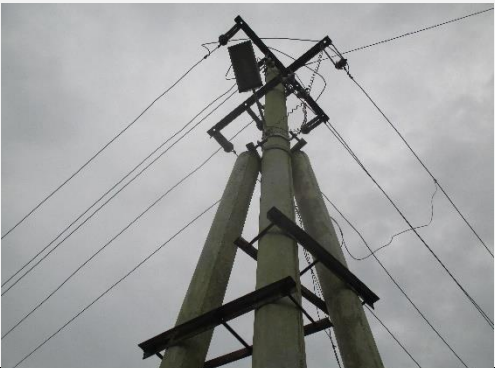
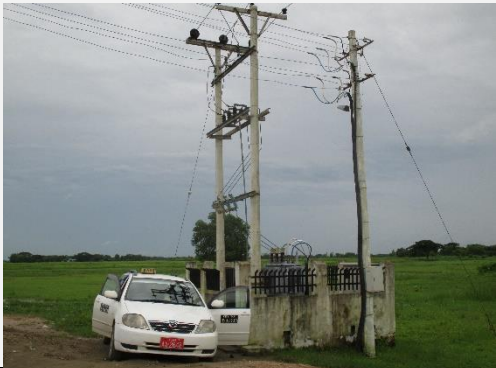
Photos

- Electricity comes regularly.
- Electric poles and transformer are supported in good foundation.
- But, there is a hole at an electric pole which was hit by a truck car. The electric pole needs to be renovated.

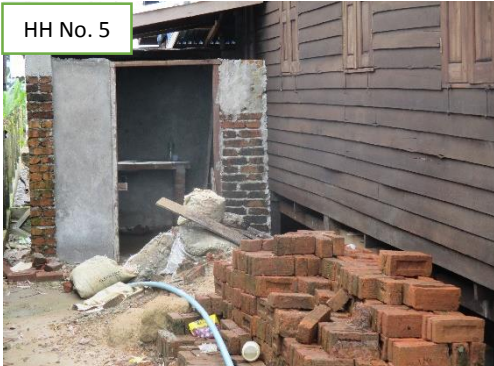
| No | Item | Condition | Description and Photos | | | | | | | | | | | | | | | | | |
|---|---|---|---|---|---|--|---|---|---|---|---|---|---|---|---|---|---|---|---|---|
| 2 | House Construction | No. of houses not completed (2) | <p><u>Description</u> -HH No.5, the construction for kitchen, toilet and water tank seems to be started again.</p>

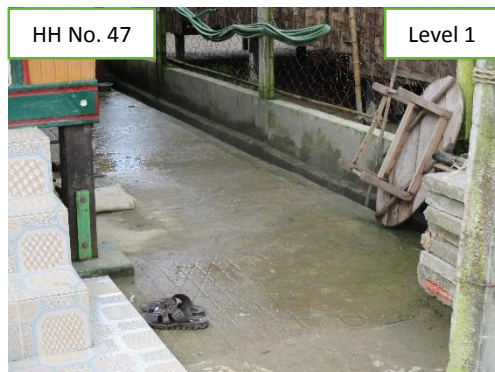
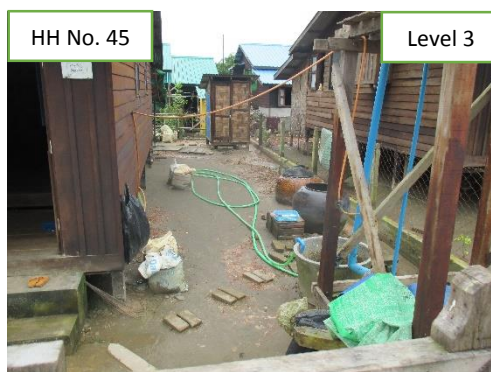
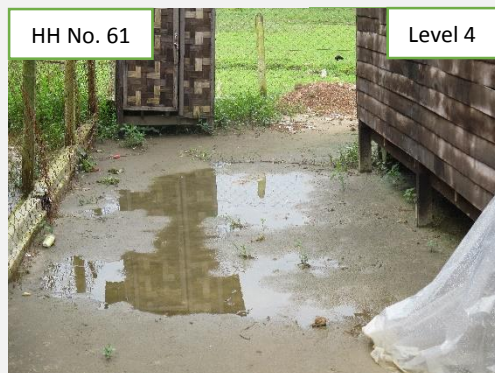
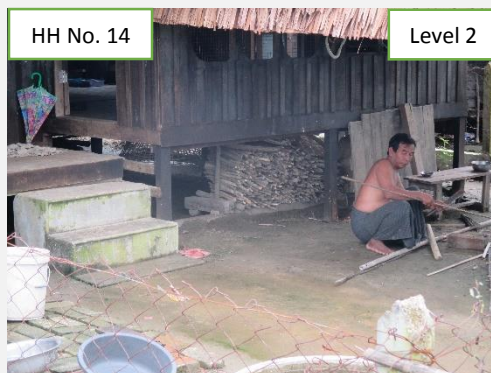
Photos

| | | | | | | | | | | | | | | | | |
| 3 | Living Status of PAPs (Sold house, renting, etc.) | <p><u>Description</u></p> <p>(1) House ownership (1)-1 No. of house that are owned by PAPs (50) (1)-2 No. of house that were sold (18)</p> <p>(2) Living condition (2)-1 No. of houses where PAPs live (41) (2)-2 No. of houses where not original PAPs lives (22) (2)-3 No. of houses where nobody lives (5)</p> <p>Location Map: See ANNEX.2</p> | | | | | | | | | | | | | | | | | | |
| 4 | Other issue | | <p>(1). Drainage condition for rain water in their compounds</p> <p><u>Description</u> -Rainy season has been started. -Most of the compounds are wet.</p>

<p><Evaluation Criteria></p> <p>Level 1 -No mud and no standing water with their own drainage system in their compound</p> <p>Level 2 -No mud and no standing water in their compound</p> <p>Level 3 - Some or little mud and standing water in their compound</p> <p>Level 4 -A lot of mud and standing water in their compound</p> | Condition | No. of HHs | | This week condition | Previous week condition | Level 1 | 14 | 14 | Level 2 | 30 | 30 | Level 3 | 20 | 20 | Level 4 | 4 | 4 |
| Condition | No. of HHs | | | | | | | | | | | | | | | | | | | |
| | This week condition | Previous week condition | | | | | | | | | | | | | | | | | | |
| Level 1 | 14 | 14 | | | | | | | | | | | | | | | | | | |
| Level 2 | 30 | 30 | | | | | | | | | | | | | | | | | | |
| Level 3 | 20 | 20 | | | | | | | | | | | | | | | | | | |
| Level 4 | 4 | 4 | | | | | | | | | | | | | | | | | | |

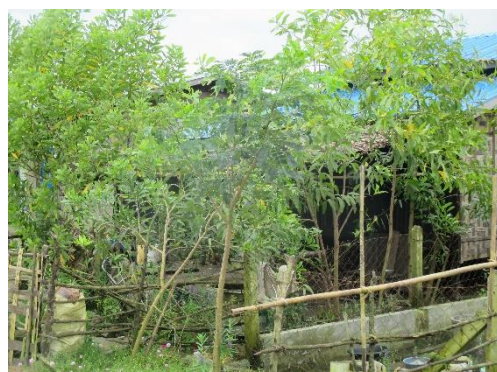
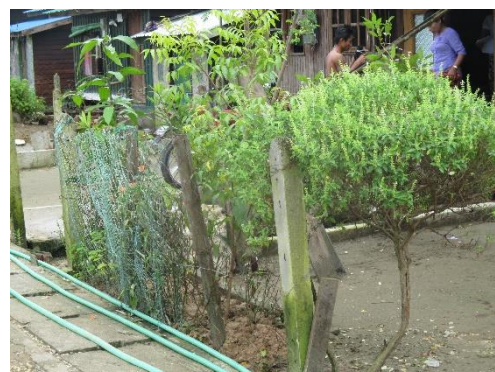
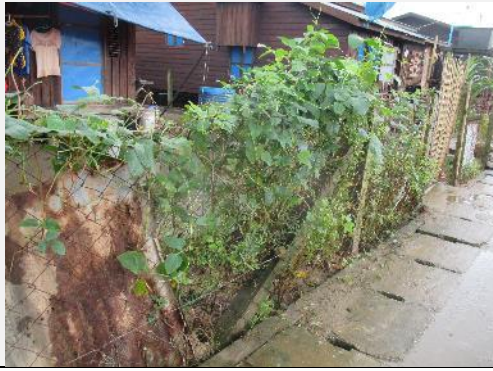
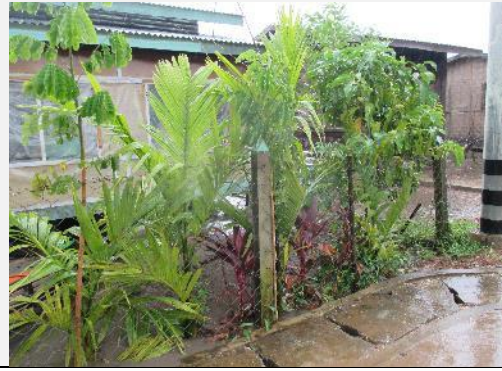
4 (2) Plantation

-In front of their compounds, they planted shady trees, fruit trees, vegetables and floral plants.

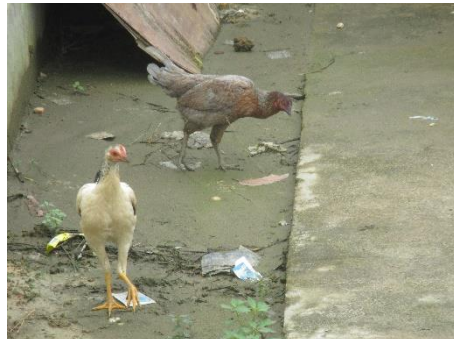
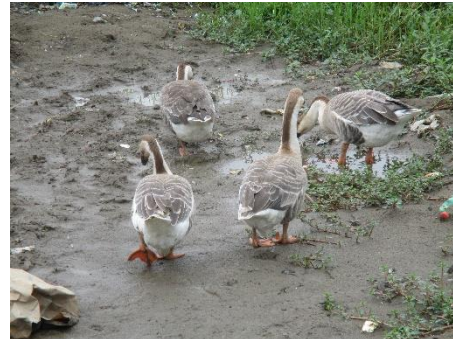
4 (3) Livestock

-They are raising chicken, ducks, goats, pigs and cows.
 -Even though they have cows, they do not keep their cows in relocation site instead they keep in their farms or other places.

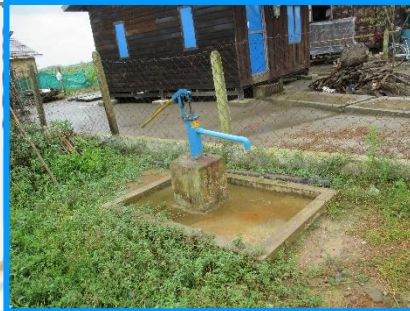
Water is clean and people nearby are using it for drinking and living use. A pulley wheel, bucket and a rope have been set up but the rope seems to be thin and it is better to be changed with thick one for the better use.

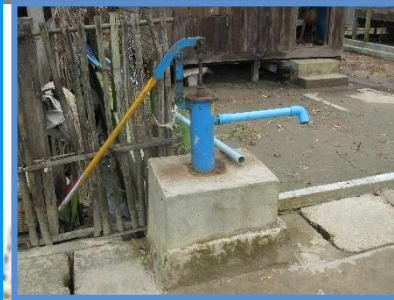
This hand pump is not functioned very well and need to change the buffer . Currently the PAP use the well and rain water instead of this hand pump.

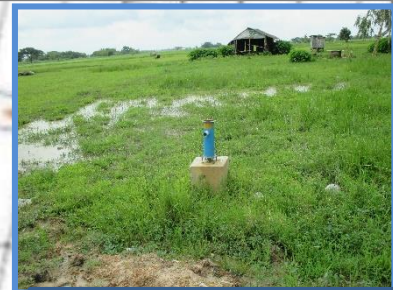
This hand pump is functioned very well. Water is clean and everyone nearby using this hand pump for drinking water and living use.

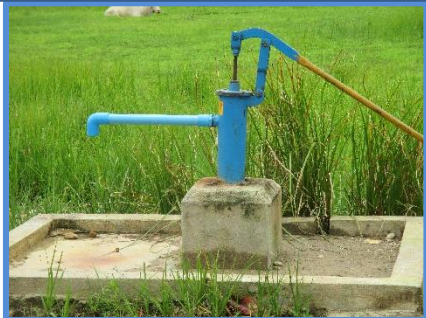
The buffer of the hand pump needs to be change. Therefore, people living nearby are using water from their owned pump or rain water at the moment.

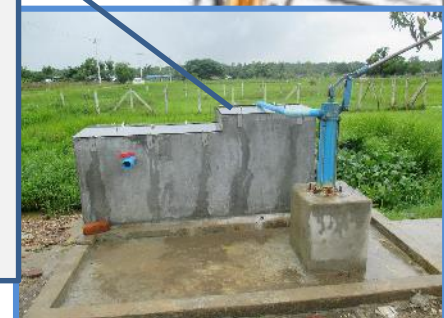
This hand pump is functioned very well. Water is clean and everyone living nearby is using this hand pump. Moreover water filter tank for remove the smell of iron has been set up beside the hand pump. There is no smell of iron and people enjoy water for drinking and living use.

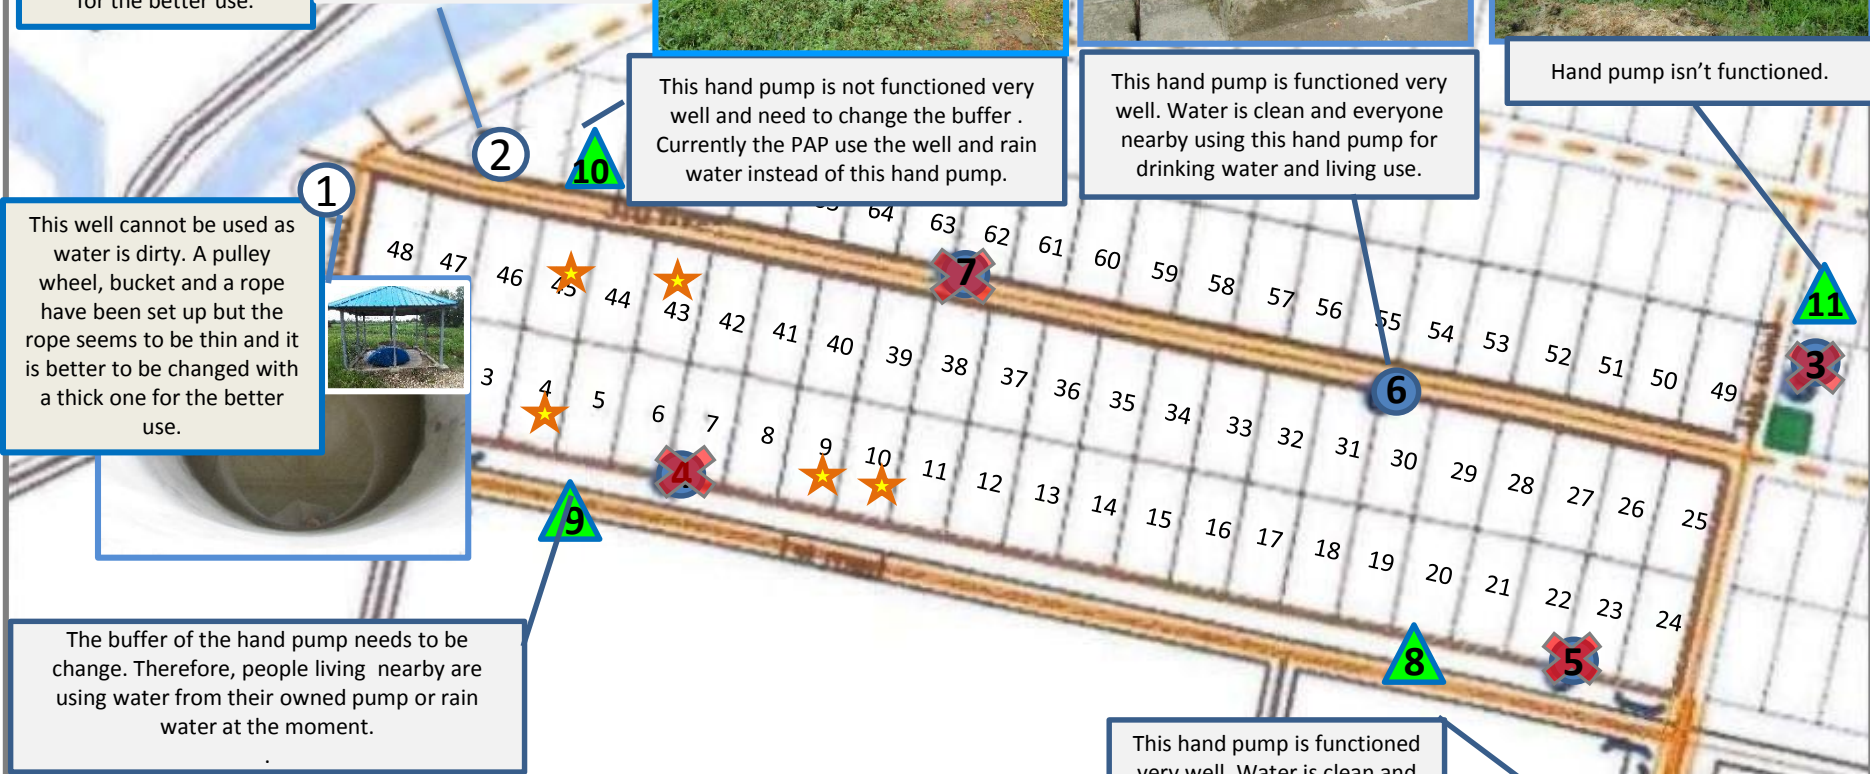
Private Well

| No | Item | Condition | Description and Photos |
|---|---|---|---|
| | (1). Well | Improved <input type="checkbox"/> Same <input checked="" type="checkbox"/> * Worse <input type="checkbox"/> <i>*as last week</i> | Description & Photos: -See ANNEX.1 - Although both of the two wells are dirty with outside water last week, well no. 1 is gradually clean this week and surrounding people are using it again. In terms of avoiding outside water, both wells need to be renovated again in summer. The buffer of some hand pumps need to be changed, but people get water from their owned well of rain water currently. |
