Surveyor: Zaw La

Date Visited: 3.9.2015

No	Item	Condition	Description and Photos
1	Condition of -		
	(1). Well	Improved <input type="checkbox"/> Same <input checked="" type="checkbox"/> * Worse <input type="checkbox"/> <i>*as last week</i>	Description & Photos: -See ANNEX.1 - Although both of the two open wells are dirty. It seems that muddy water under the ground is passing through the crack at the wall of the well. Compared with last week, well no. 1 is gradually clean this week and used by surrounding people again. In terms of avoiding the muddy water under the ground passing to the well, both open wells need to be renovated again in summer. The buffers of some hand pumps need to be changed, but people get water from their own well or rain water currently.

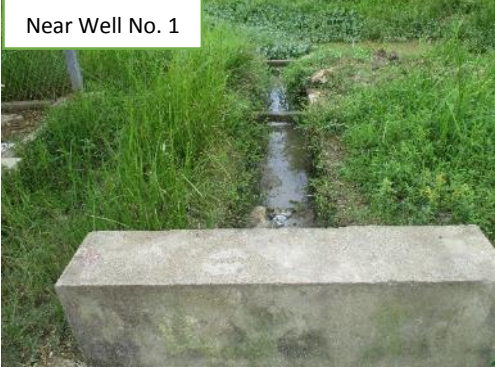
<p>Near Well No. 1</p> </div> <div style="width: 50%; text-align: center;">

(2). Drainage	Improved <input type="checkbox"/> Same <input checked="" type="checkbox"/> * Worse <input type="checkbox"/> <i>*as last week</i>	Description -Water level in the drainage canals is lower than last week because there was a small amount of rain last two days ago. But, the stream along the drainage canal may need to be rehabilitated in order to improve the water-flow in coming summer period. Photos <div style="display: flex; flex-wrap: wrap;"> <div style="width: 50%; text-align: center;">

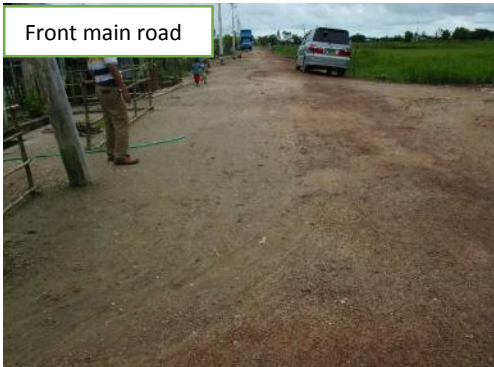
(3). Road	<p>Improved <input type="checkbox"/></p> <p>Same <input checked="" type="checkbox"/>*</p> <p>Worse <input type="checkbox"/></p> <p><i>*as last week</i></p>	<p><u>Description</u></p> <p>-The roads are being wet and muddy in some areas but no problem for walking.</p> <p><u>Photos</u></p>

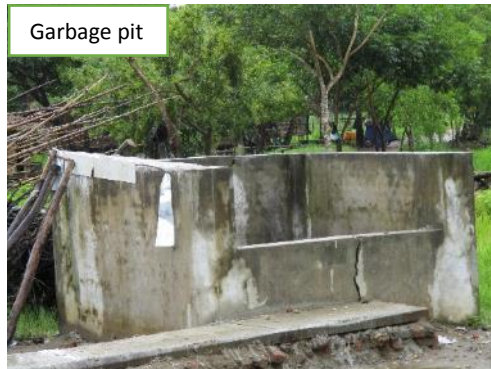
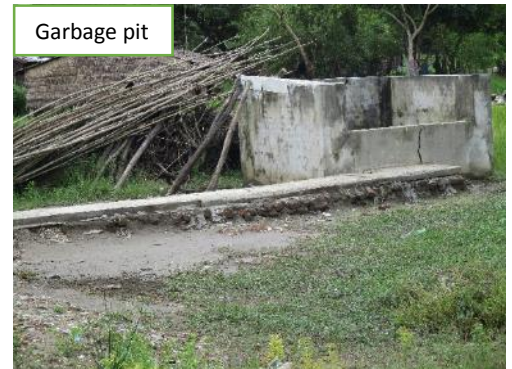
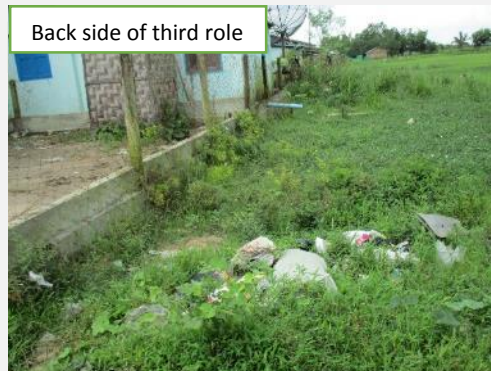
(4). Garbage Condition	<p>Improved <input type="checkbox"/></p> <p>Same <input checked="" type="checkbox"/>*</p> <p>Worse <input type="checkbox"/></p>	<p><u>Description</u></p> <p>-Garbage pit is being used by people.</p> <p>-Garbage pit was cleaned and a new access way to garbage pit had been constructed.</p> <p>-There is no problem for smelling from the garbage pit at the moment.</p> <p>-People throw garbage at the backside of Third Row and it need to be collected.</p>

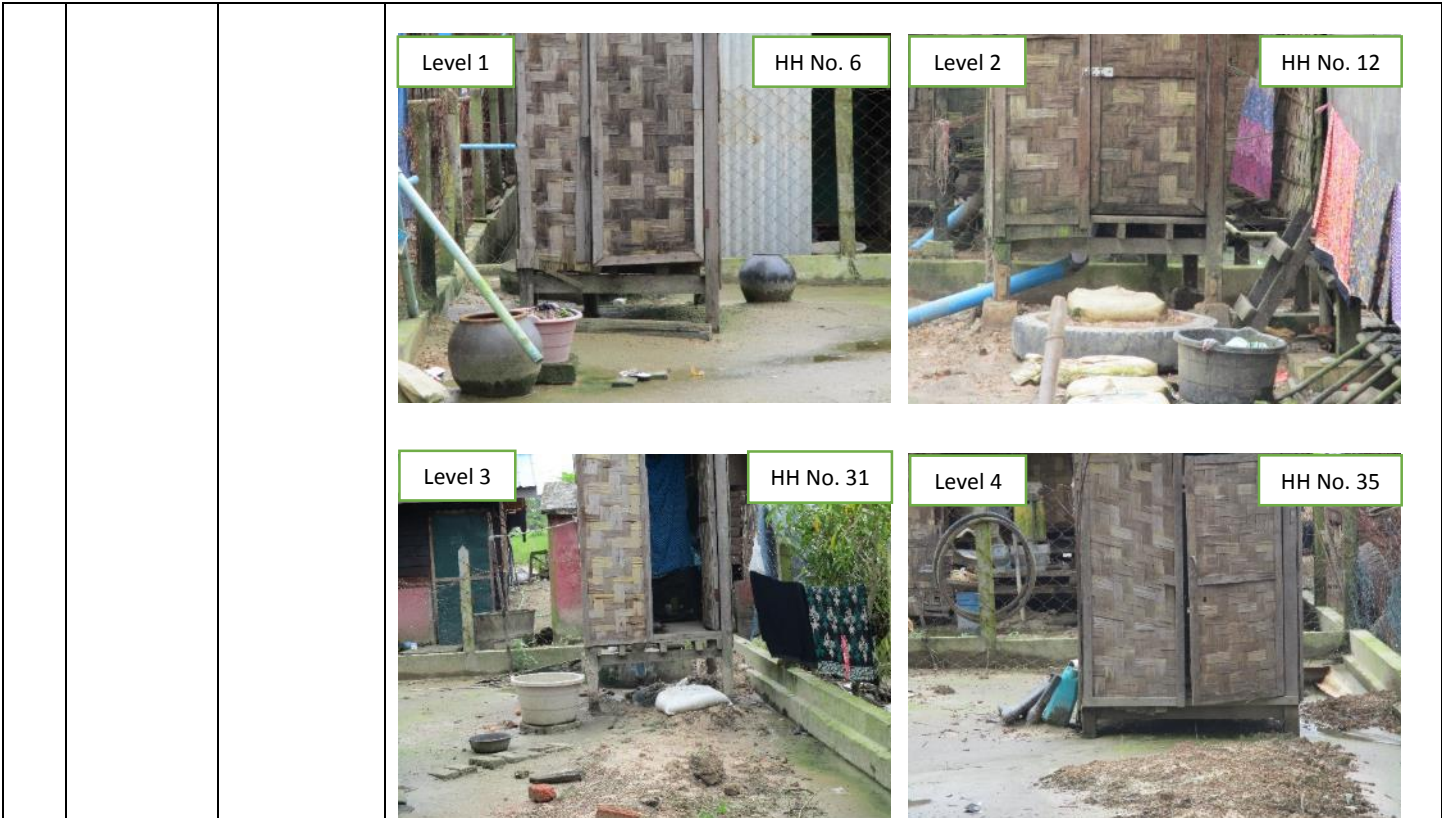
-All of fly proof toilets are used by people.
-Some fly proof toilets have been lifted up like HH no. 12 and HH no. 31 as shown in below pictures. If the toilet is not lift up, groundwater level will be raised up when there is heavy rain and will be inconvenient to use. Some toilets are still needed to be lifted up.

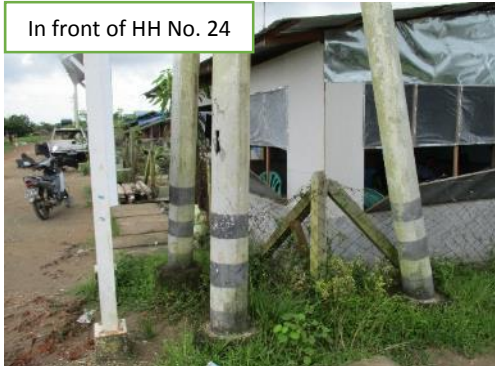
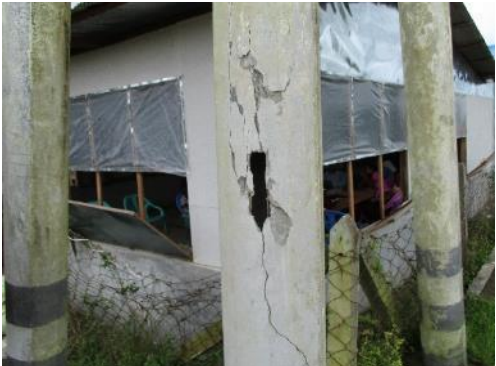
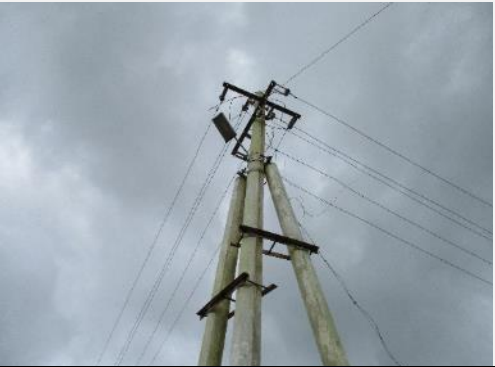
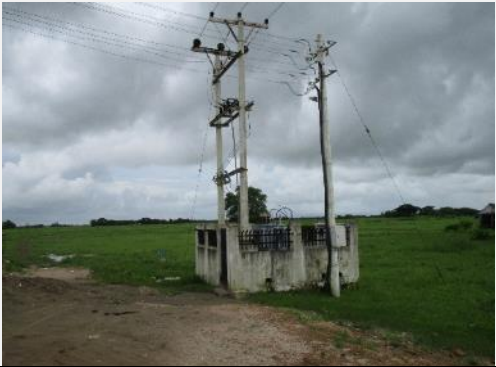
- Electricity comes regularly.
- Electric poles and transformer are being supported with a good foundation.
- But, there is a hole at an electric pole which was hit by a truck car. The electric pole needs to be renovated.

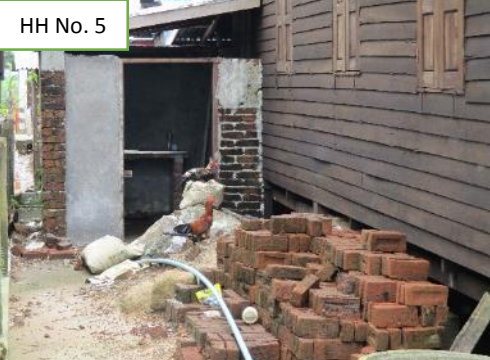
No	Item	Condition	Description and Photos																	
2	House Construction	No. of houses not completed (2)	<p><u>Description</u> -HH No.5, the construction for kitchen, toilet and water tank seems to be started again.</p>

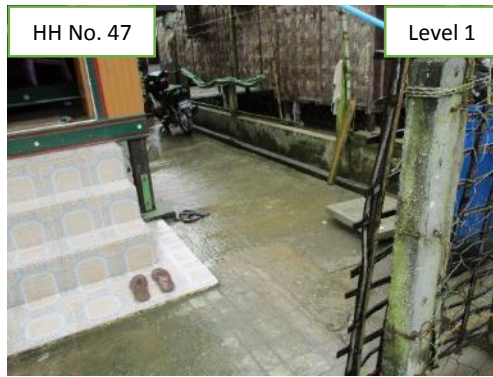
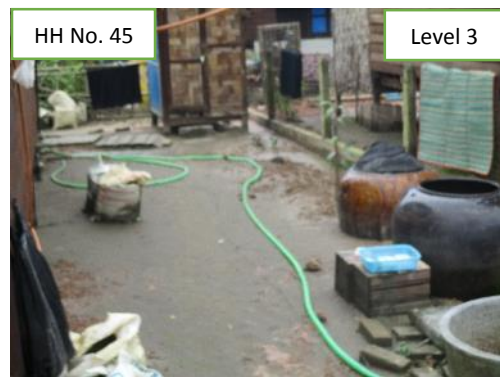
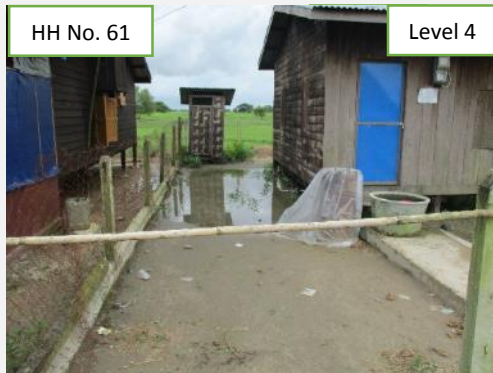
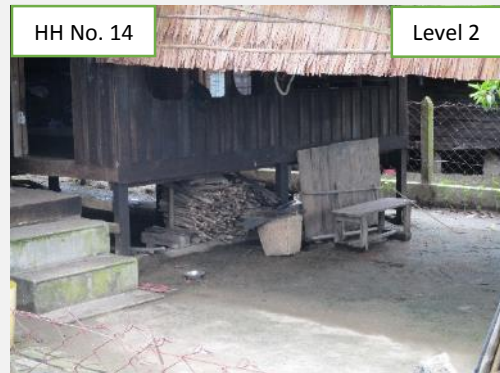
3	Living Status of PAPs (Sold house, renting, etc.)	<p><u>Description</u></p> <p>(1) House ownership (1)-1 No. of house that are owned by PAPs (50) (1)-2 No. of house that were sold (18)</p> <p>(2) Living condition (2)-1 No. of houses where PAPs live (41) (2)-2 No. of houses where original PAPs lives do not live (22) (2)-3 No. of houses where nobody lives (5)</p> <p>Location Map: See ANNEX.2</p>																		
4	Other issue		<p>(1). Drainage condition for rain water in their compounds</p> <p><u>Description</u> -Rainy season has been started. -Some of the compounds are wet.</p>

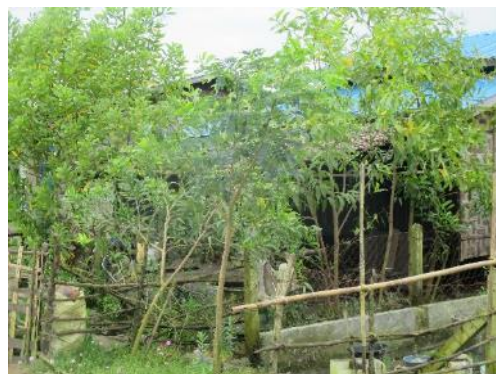
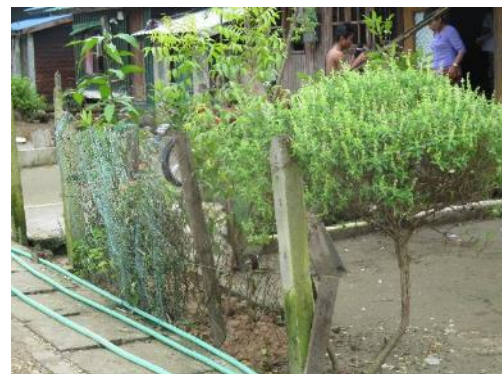
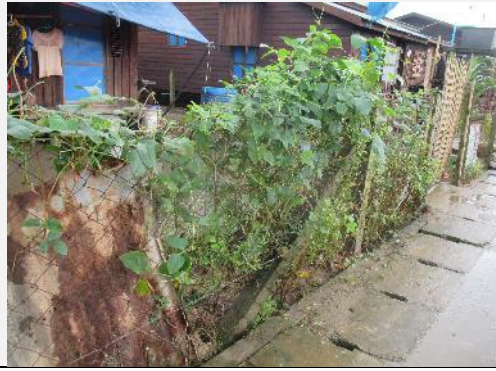
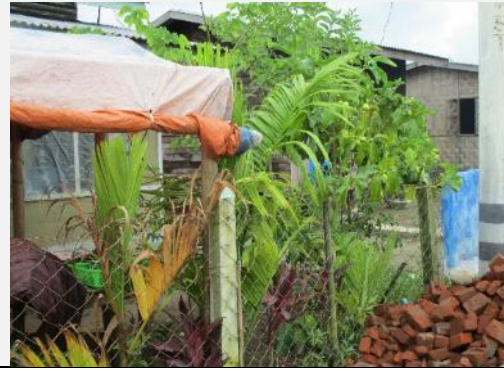
-In front of their compounds, the people planted shady trees, fruit trees, vegetables and floral plants.

Type	No. of HHs	Remarks
Shady tree	12	Albizia, Indian almond, etc. HH No. 2, 3, 14, 19, 20, 21, 25, 27, 29, 32, 41 and 65
Fruit tree	24	Banana, Mango, sugarcane, coconut, citrus, etc. HH No. 2, 3, 4, 7, 8, 9, 11, 17, 21, 24, 25, 27, 33, 37, 38, 39, 41, 43, 45, 46, 47, 48, 54 and 65
Vegetable	10	Spices, peas, roselle, etc. HH No. 22, 23, 25, 27, 38, 39, 40, 42, 45 and 63
Floral plant	20	Many species. HH No. 2, 9, 14, 15, 17, 21, 23, 27, 32, 33, 38, 39, 40, 41, 42, 43, 47, 48, 58 and 65

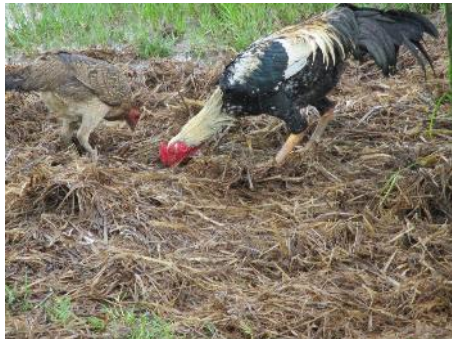
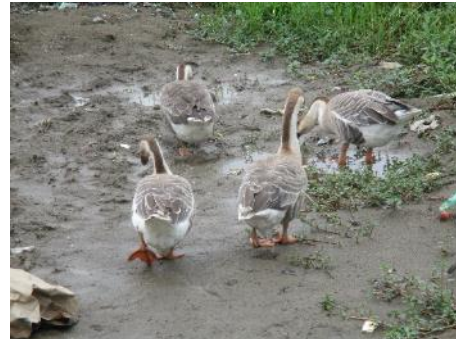
Photos

-The people are raising chicken, ducks, goats, pigs and cows.
 -Even though they have cows, some houses do not keep their cows in relocation site instead they keep in their farms or other places.

Type	No. of HHs	Remarks
Cow	5	HH No. 1, 3, 18, 42, 47 and 54
Pig	-	-
Goat	1	HH.47
Chicken and ducks	15	HH No. 4, 8, 12, 14, 28, 30, 32, 41, 47, 50, 51, 52, 55, 56 and 62

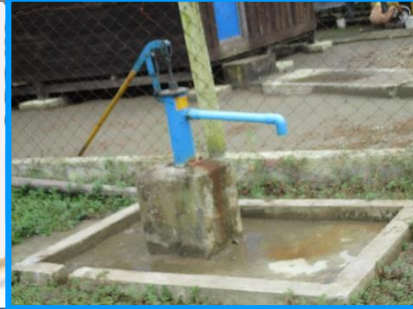
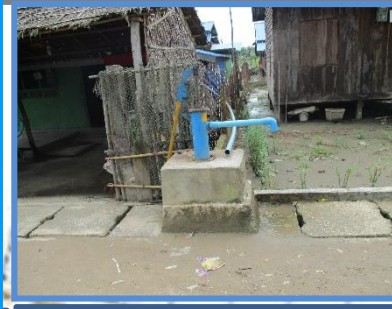
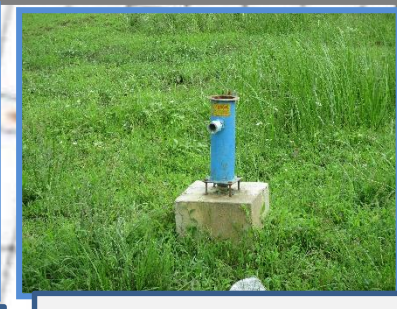
Water is clean and people nearby are using it for drinking and living use. A pulley wheel, bucket and a rope have been set up but the rope seems to be thin and it is better to be changed with thick one for the better use.

Hand pump isn't functioned.

As the buffer has been changed with the new one and the hand pump is functioned very well now. Water is also clean and people living nearby use it for drinking and living use again.

This hand pump is functioned very well. Water is clean and everyone nearby using this hand pump for drinking water and living use.

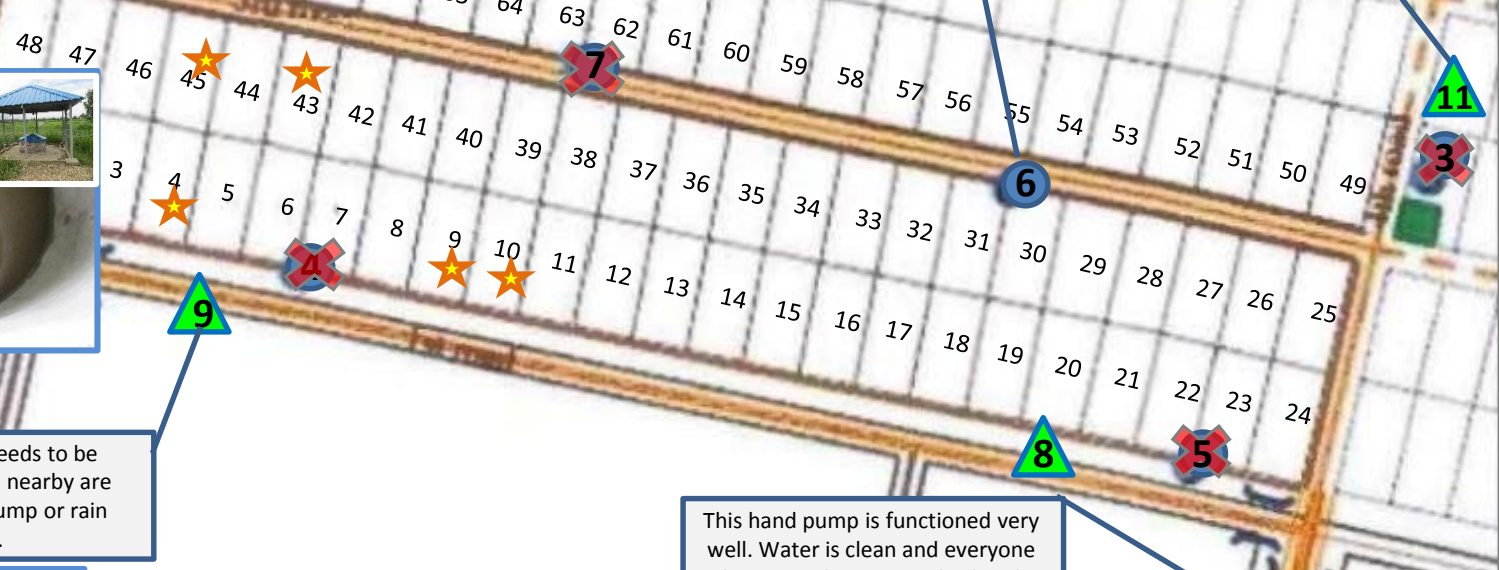
This well cannot be used as water is dirty. A pulley wheel, bucket and a rope have been set up but the rope seems to be thin and it is better to be changed with a thick one for the better use.

The buffer of the hand pump needs to be change. Therefore, people living nearby are using water from their owned pump or rain water at the moment.

This hand pump is functioned very well. Water is clean and everyone living nearby is using this hand pump. Moreover water filter tank for remove the smell of iron has been set up beside the hand pump. There is no smell of iron and people enjoy water for drinking and living use.
